**Project Title** Murgatroyd's Brine Pump (Stage 2)  
**Client** Middlewich Town Council  
**Location** Middlewich

**Drawing Title** Proposed  
Floor Plan

Drawing ref	Job No	Drawing No	Revision
	8402	(04) 001	C

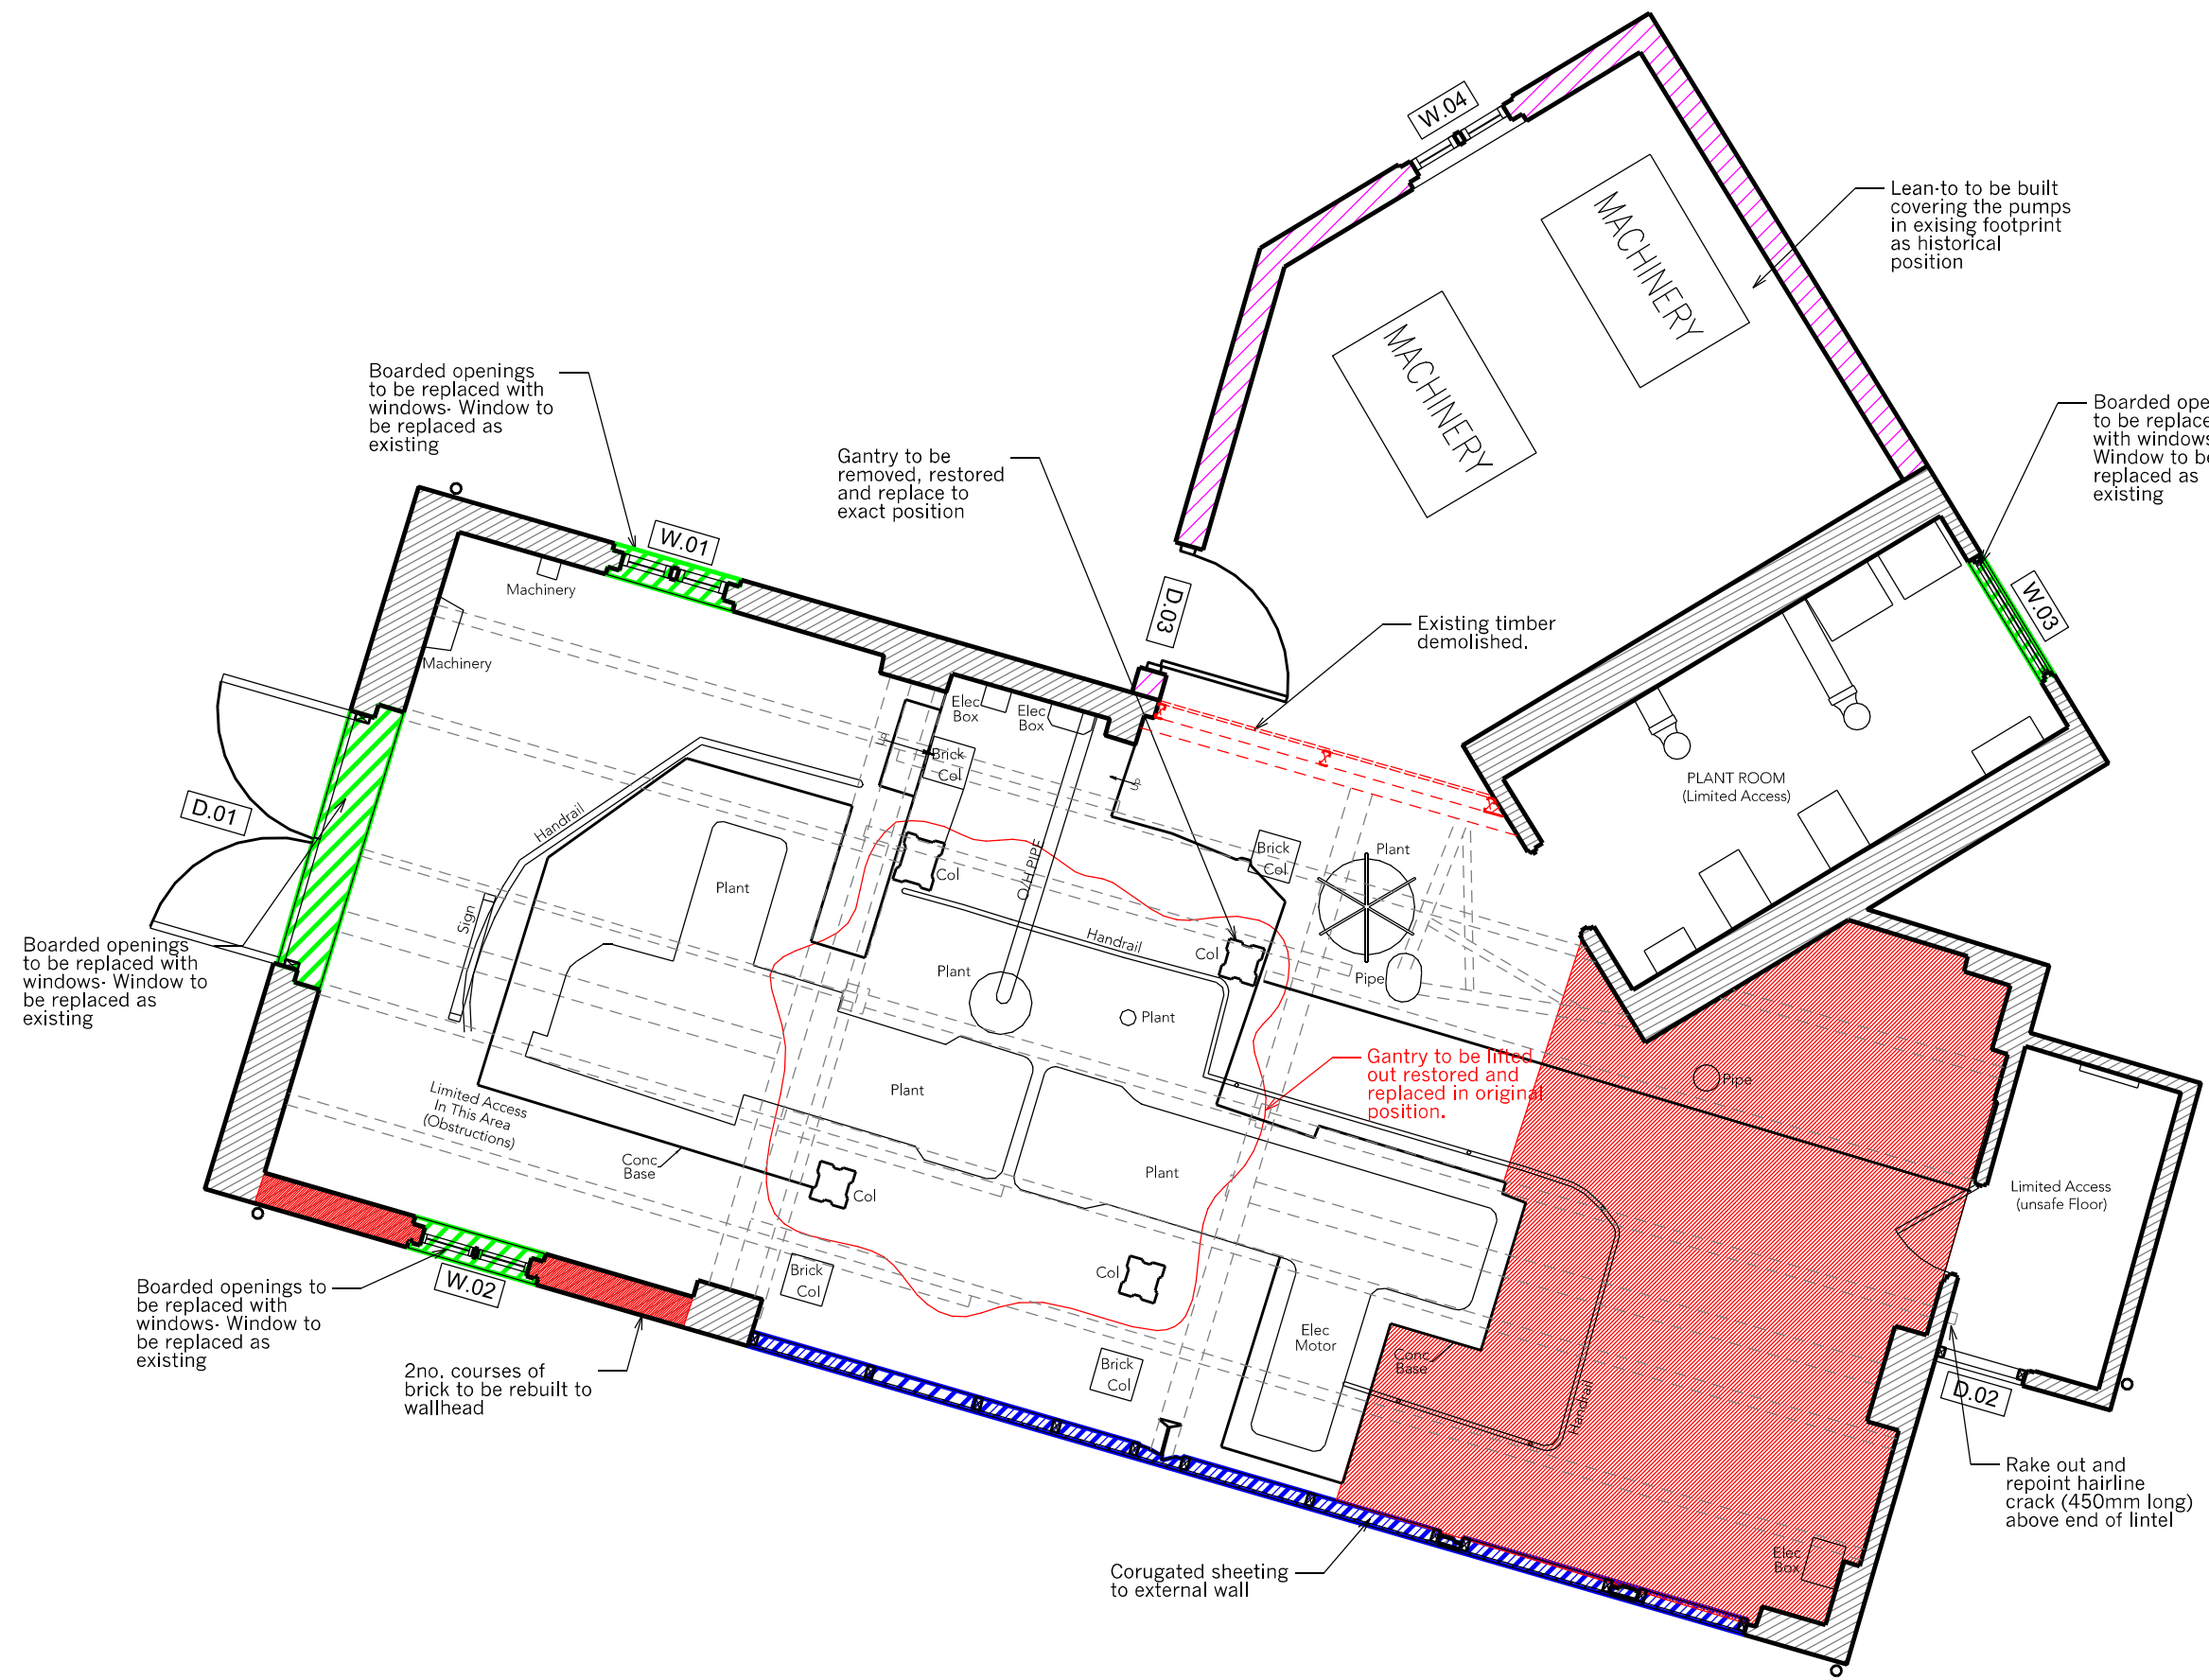
Existing timber demolished.

Rake out and repoint hairline crack (450mm long) above end of lintel

- Water tank and pipes to be reinstated
- Windows and Doors to be replaced like for like
- All vegetation growth & debris to be removed
- Corrugated sheeting to be applied to external wall
- Remove asbestos wall sheeting and replace with robust timber boarding.
- Rebuild existing Lean-to
- Area of wall to be rebuilt
- Area of wall to be repointed
- Demolition
- Gantry to be removed, restored and replaced
- Area of floor to be removed and replaced

Boarded openings to be replaced with windows- Window to be replaced as existing

Gantry to be removed, restored and replace to exact position

Lean-to to be built covering the pumps in existing footprint as historical position

Gantry to be lifted out restored and replaced in original position.

2no. courses of brick to be rebuilt to wallhead

Corrugated sheeting to external wall
