Project Title	Murgatroyd's Brine Pump	Project No	8402			
Compiled By	EG	Date	07/07/20			
То	Kerry Kirwan, Richard Granton, Mark Newton, Emily Green, Stephen Anderson	Company	Buttress			
		Page No:	1 of 2			
Work Item:	Description: The front door frame has not been painted adequately					
Doors generally	Screws left protruding to the rear of the door, sharp and unsafe.					
Doors generally	Rear door frame base is rotten, door is too small and therefore does not close properly.					
Windows generally	Paint finish is not adequate in a number of areas.					
Windows generally	Wire used to tie the side window shut is protruding.					
Flashing	Flashing has been attached to unsightly wooden panelling. It has not been installed as per detailed produced.					
Brick work	Mismatch of mortar colour has been used around the brine tank.					
Rubbish	Rubbish has been left on site in several areas.					
Guttering	Guttering has been dislodged in a few places during the roof works and has not been put back as before.

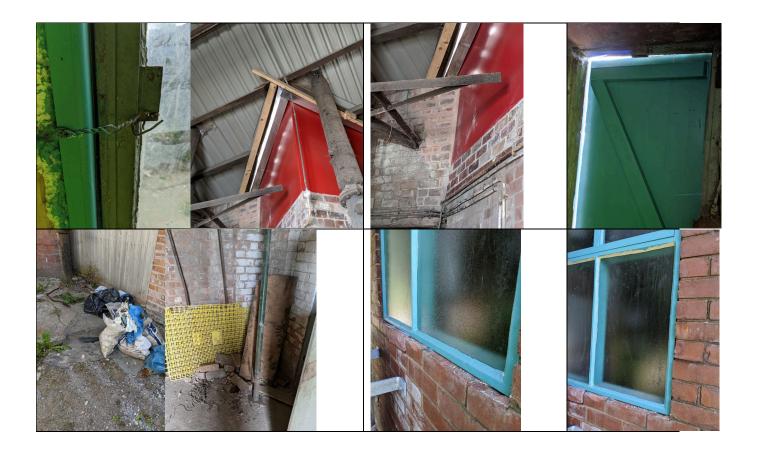
Rear window	Rear window has not been fitted adequately, loose bricks beneath the window and pain finish insufficient.
