# Site Visit Report

<b>Project Title</b>	Murgatroyd's Brine Pump Emergency Works	<b>Project No</b>	8402
<b>Client</b>	Middlewich Heritage Trust	<b>Date</b>	08.01.20
<b>Purpose</b>	Site Progress and Observations	<b>Visit By</b>	EG

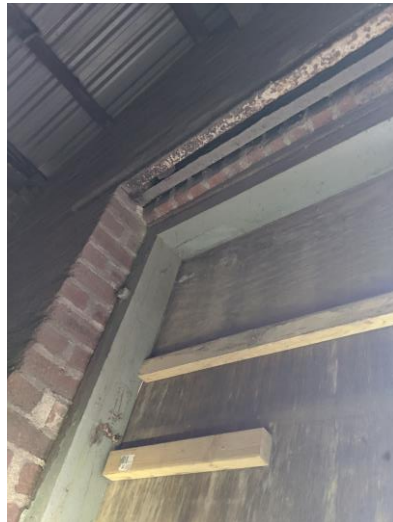
Figure 2 Windows/door frames looked at and scope with contractor

**Figure 2/3 Scope of window and door replacement discussed on site with contractor and client**

Costs to be revised by Quadriga according to discussion

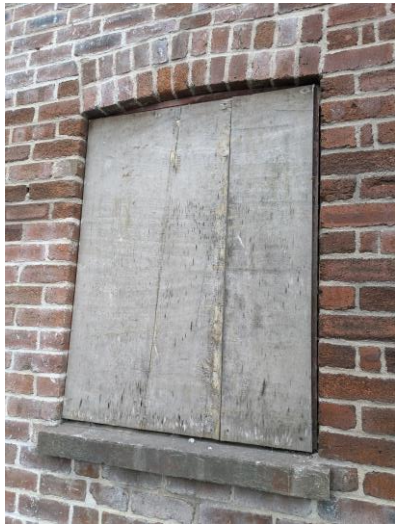
Figure 3 *Widows looked at externally*

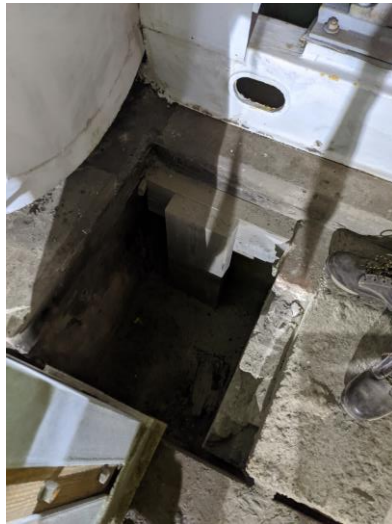
Figure 4 Timbers noted to be missing

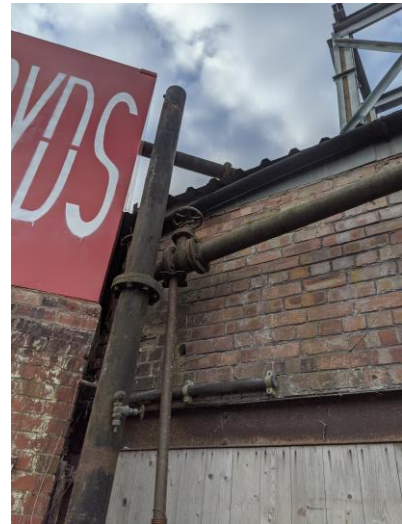
Figure 5 Pipe resting on pole

**Figure 5 Client pointed out loose gutter and also pipe propped up by scaffold pole**

Quadriga agreed to fix loose gutter and agreed to remove the hanging pipe temporarily for the client to store as they wish, due to the safety hazard of it remaining as it is.

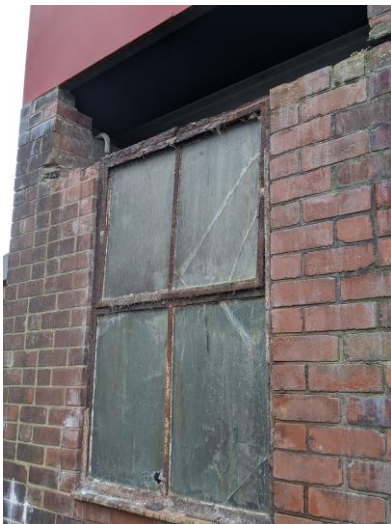
Figure 6 *Gap and Window discussed*

**Figure 6 Brick gap and window replacement discussed with client**

Quadriga to include for a cost to replace this window, both like for like and a hard wood version. Buttress to liaise with HE regarding the replacement. Buttress to instruct how the gap will be resolved once window/lintel scope is established.

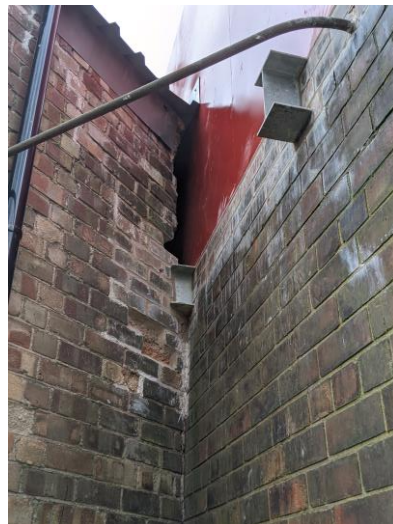
Figure 7 Missing gutter

**Figure 7 Gutter hasn't been reinstated after flashing detail was installed**

Quadriga to rectify this issue as soon as possible

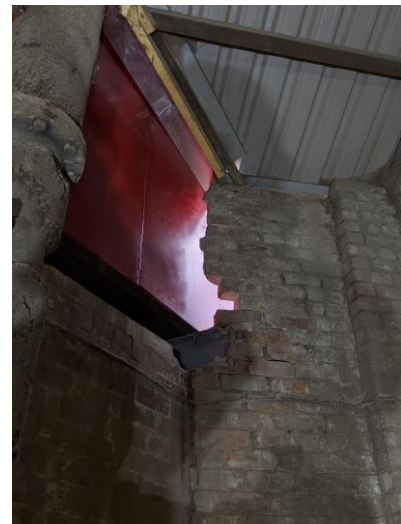
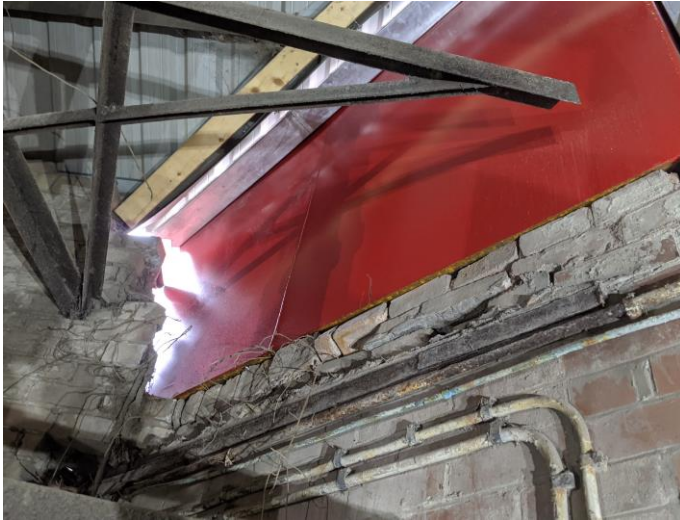
Figure 8 Gaps at the side

**Figure 8 Gaps at the side**

**Figure 8 Quadriga requested details from Buttress regarding the gaps at the side of the Brine Tank**

Buttress to produce a detail for costing to address the gaps at the side of the brine tanks, once costed Buttress will instruct formally.
