Murgatroyd Pump Shaft Discussion of Observations from FLODIM Sonar Survey

The report was carried out by Flodim, on behalf of Robertson Geologging to assess the condition of the pump shaft at the Murgatroyd Pumping Station.

The visit took place on 8th March 2017

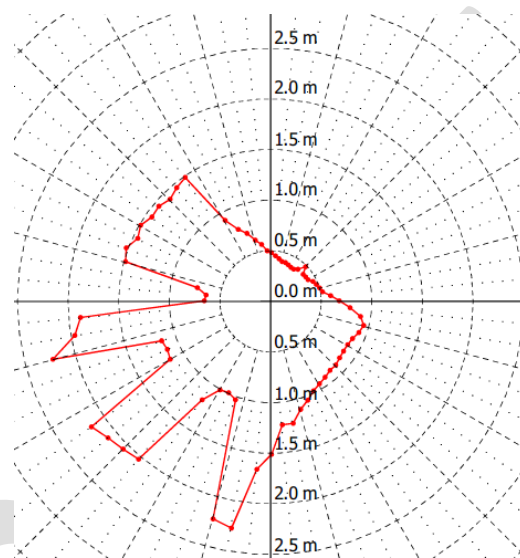
Figure 5 – Typical horizontal section

Each red dot represents a single distance reading. This reveals a square shaft aligned, roughly, NE – SW.

The three indents are the pump delivery pipes running vertically up the shaft. Clearly, if the sonar signal is reflected by the pipe, it is prevented from reaching the shaft wall behind the pipe. This causes a series of acoustic “shadows” behind the pipes, where no detail can be detected.

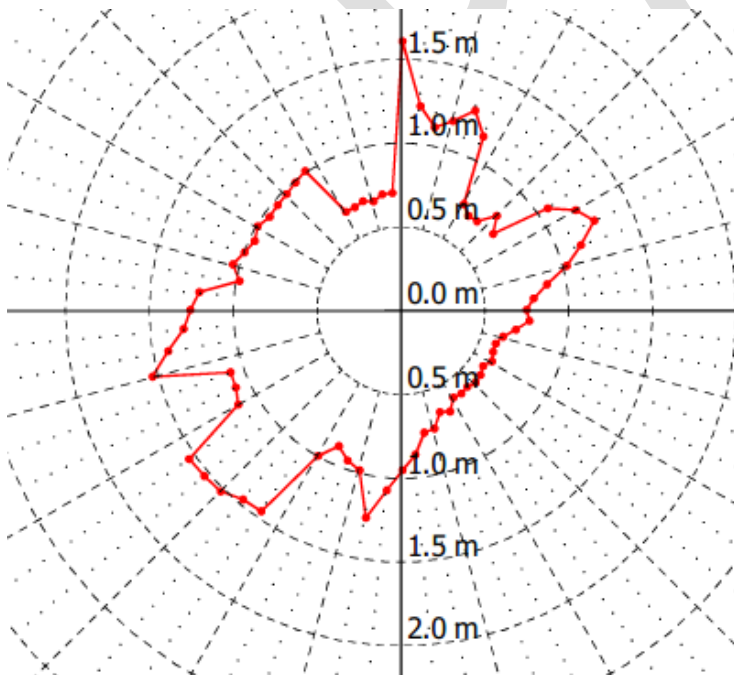
Figure 8 – 25m Level – Submersible riser now absent

The angular distance between readings is 5° , i.e. the beam moves 90 -100 mm between readings so, for a 250 mm dia riser, it is likely that the probe will hit it two or three times on each sweep. This is confirmed by the scans from the 25m level, showing three hits and four hits respectively on the two riser pipes.

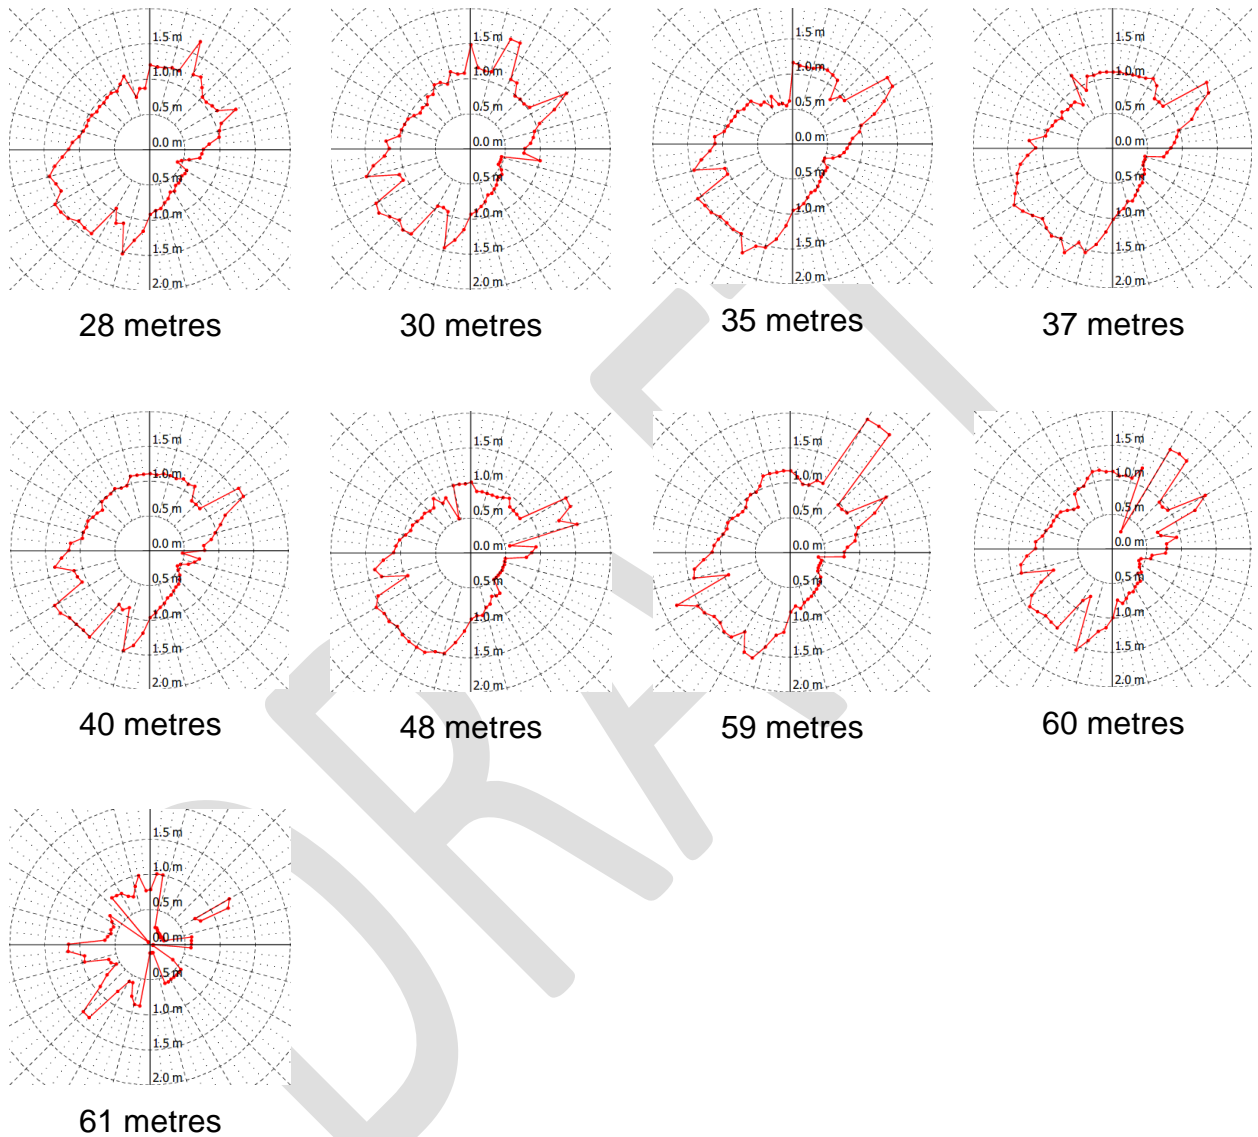
Figure 9 – Selected sections at various levels

- However, at 28m level, the No1 Pump Riser also disappears from the trace, reappears in a reduced form at 30m, is absent 38 & 39m, present, in reduced form 40 – 48m and is then present intermittently to 60m
- No3 pump riser disappears at 35m, reappearing at 38m, is absent from 44m, reappearing at 60m
- The trace at 61m level is very confused, and it was not possible to get the probe beyond this depth.

However, for a 40mm dia pump rod the probe will have only a 1 in 4 chance of detecting it. Signals such as this can be seen at the 48m and 59m levels.

It seems possible that the two riser pipes have broken off at a depth of about 32m. It is not known how far from the bottom the suction pipes ended, but dropping a string of cast iron pipe even a modest distance would cause the lower end to shatter.

- It would be prudent to lift the submersible pump, in case that is also dislodged by another fall.
- It is most unlikely that we can retrieve a whole John Thom pump, because the working barrel is probably tangled in the debris in the bottom part of the shaft.
- Because of this debris, it is most unlikely that we can retrieve any artefacts from the shaft or adit.
- It is very likely that the pump buckets are free, so that it will be simple to put a pump in motion without any risk of seizure, or having to dispose of pumped brine.
- If the buckets are not free, we can cut the pump rod, near the surface, confident that this will not cause significant further damage to the pumps or shaft.
