Murgatroyd Pump Shaft Discussion of Observations from FLODIM Sonar Survey

The report was carried out by Flodim, on behalf of Robertson Geologging to assess the condition of the pump shaft at the Murgatroyd Pumping Station.

The visit took place on 8th March 2017

Report No 17-3022

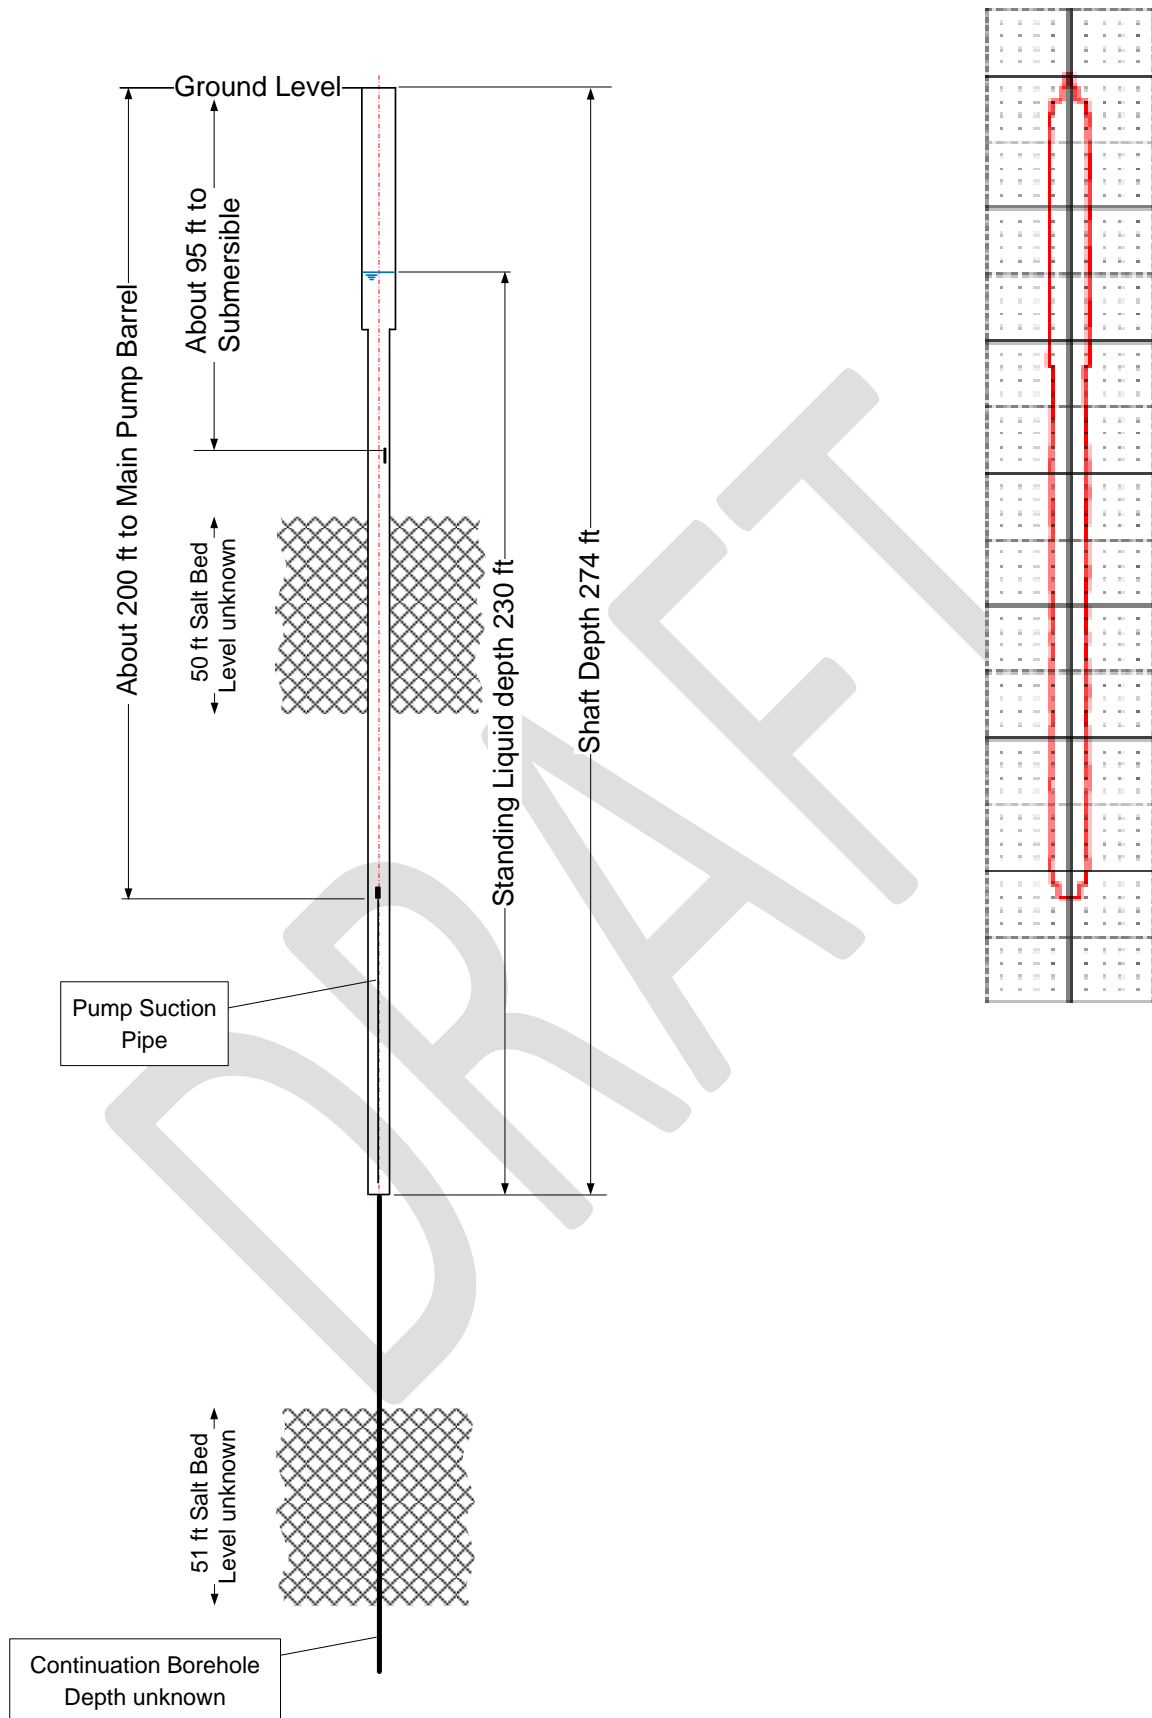
Figure 4 – Section of shaft comparing historical records with survey

- From Figure 4, it can be seen that the shaft should be much deeper than the survey suggests. An examination of the individual sections also reveals some anomalies.
- The change of section occurs between 21 & 22m. This agrees reasonably with the stated depth of “about 60 ft.”
- The Submersible Pump Riser disappears from the trace at about 25m, and is not seen again. This corresponds reasonably well with the expected depth of “about 95 ft.”

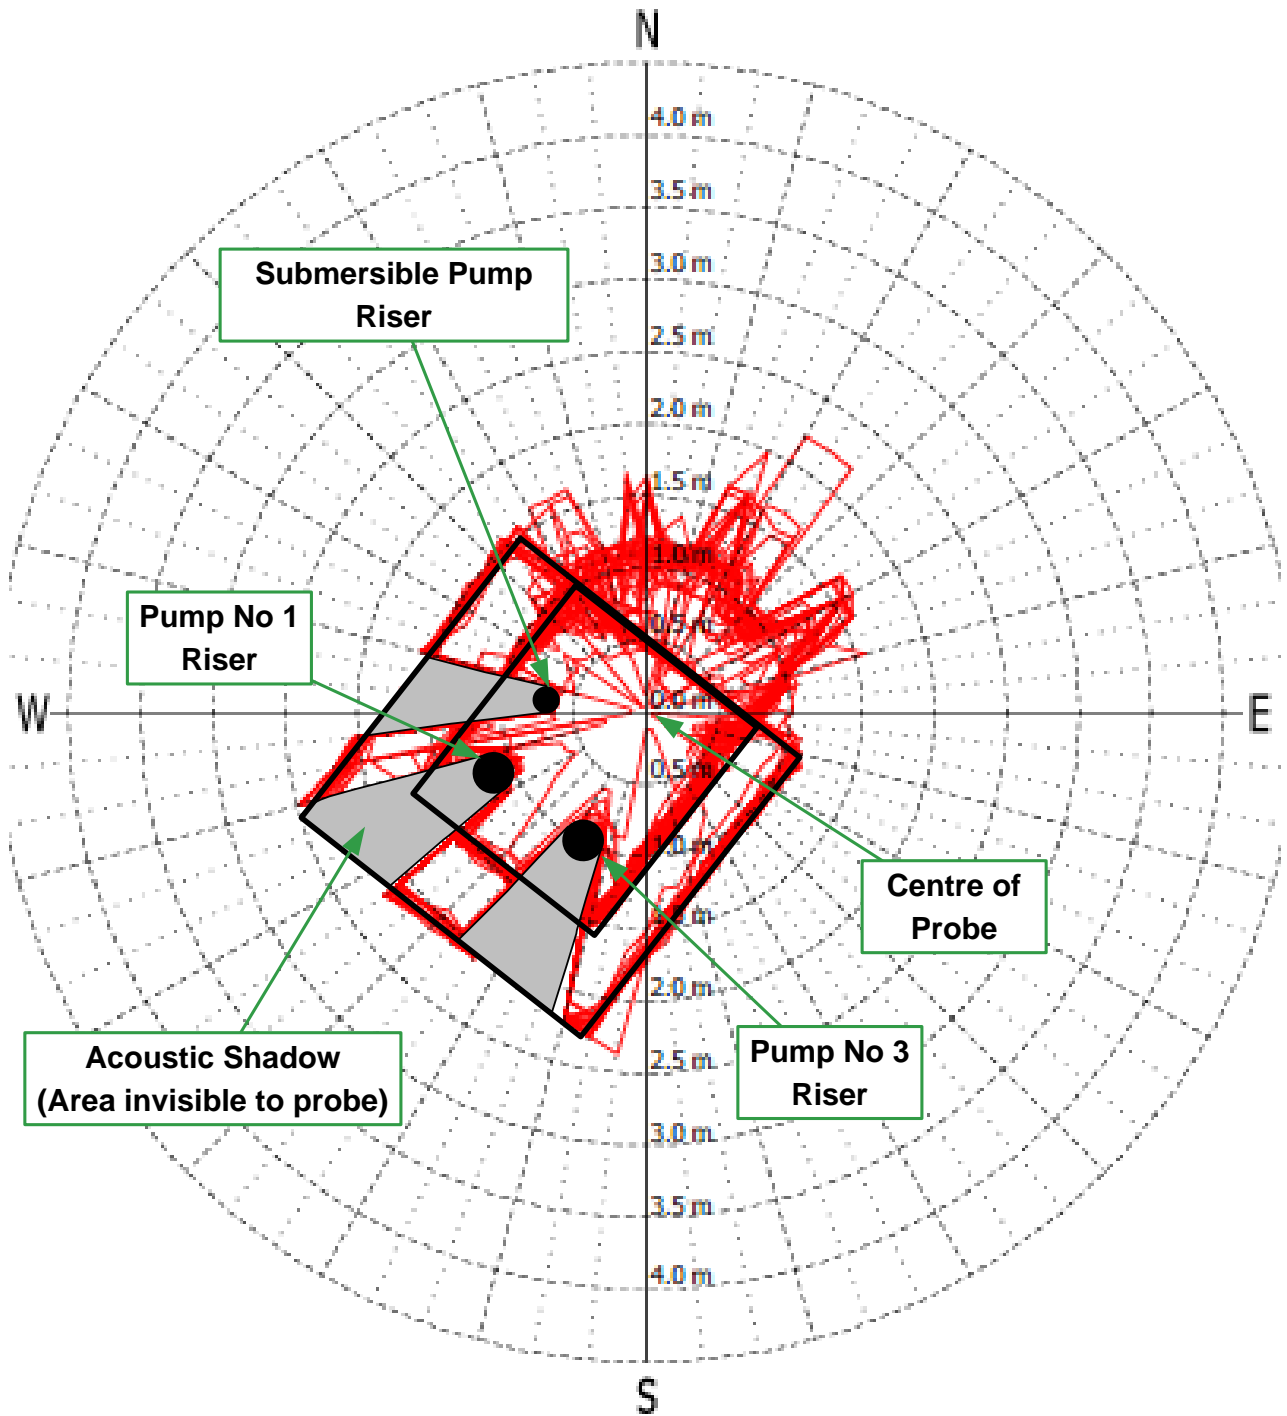
Figure 6 – Summary trace showing shaft and pipes

- The upper and lower shafts are both rectangular, as expected, but the lower shaft is offset so that there is no step in the NE wall. It can be seen from the individual sections, that the transition takes place at around 21m depth
- Either the NE wall was not so well finished as the other three, or there has been some spalling on the NE wall. The other three walls appear to be fairly uniform, with little irregularity. This suggests that the shaft is stable.

The NE shaft wall is irregular, and shows a significant loss of material between 28m and 48m depth. This may be due to solution of the salt bed but, if it were, the solution would be expected to occur in all directions. However, the other three walls show very little irregularity.

Alternatively, part of the shaft wall may have broken away. The resultant rock fall could easily have caused the damage to the riser pipes.

- It would be prudent to lift the submersible pump, in case that is also dislodged by another fall.
- It is most unlikely that we can retrieve a whole John Thom pump, because the working barrel is probably tangled in the debris in the bottom part of the shaft.
- Because of this debris, it is most unlikely that we can retrieve any artefacts from the shaft or adit.
- It is very likely that the pump buckets are free, so that it will be simple to put a pump in motion without any risk of seizure, or having to dispose of pumped brine.
- If the buckets are not free, we can cut the pump rod, near the surface, confident that this will not cause significant further damage to the pumps or shaft.

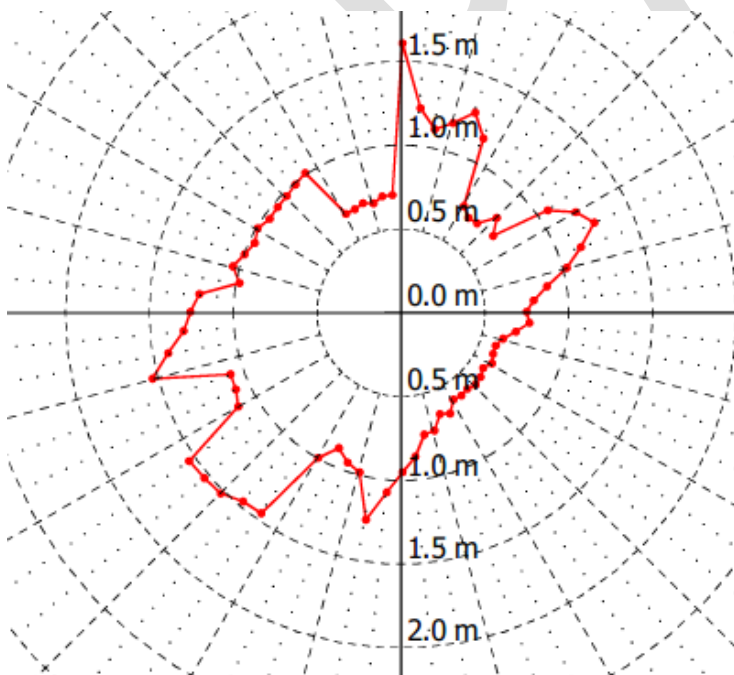
Figure 8 – 25m Level – Submersible riser now absent

The angular distance between readings is 5° , i.e. the beam moves 90 -100 mm between readings so, for a 250 mm dia riser, it is likely that the probe will hit it two or three times on each sweep. This is confirmed by the scans from the 25m level, showing three hits and four hits respectively on the two riser pipes.

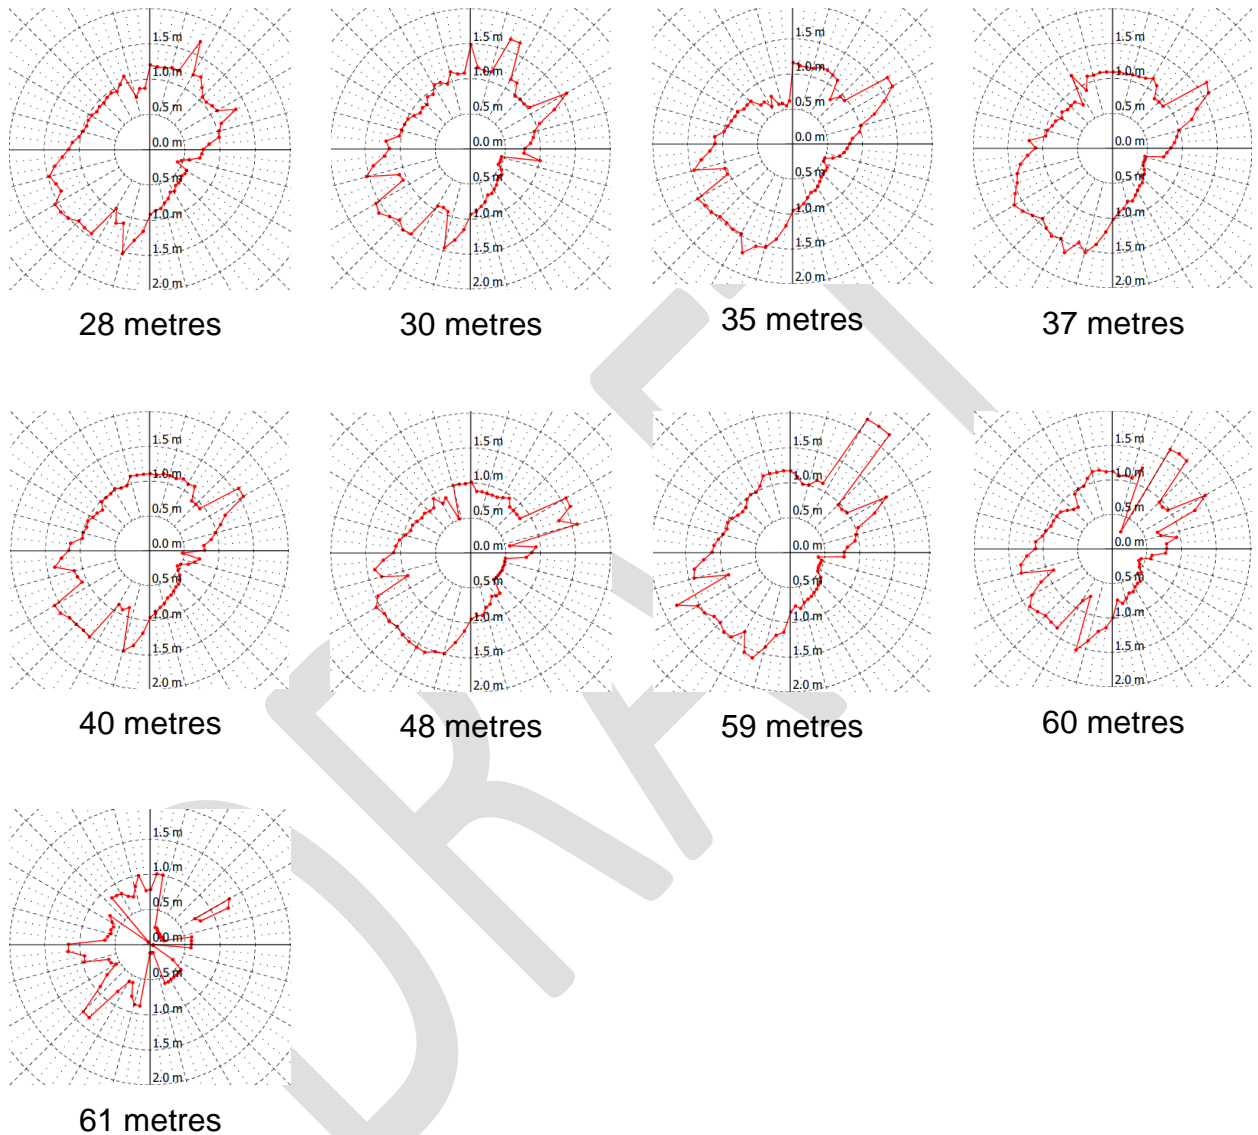
Figure 9 – Selected sections at various levels

- However, at 28m level, the No1 Pump Riser also disappears from the trace, reappears in a reduced form at 30m, is absent 38 & 39m, present, in reduced form 40 – 48m and is then present intermittently to 60m
- No3 pump riser disappears at 35m, reappearing at 38m, is absent from 44m, reappearing at 60m
- The trace at 61m level is very confused, and it was not possible to get the probe beyond this depth.

However, for a 40mm dia pump rod the probe will have only a 1 in 4 chance of detecting it. Signals such as this can be seen at the 48m and 59m levels.

It seems possible that the two riser pipes have broken off at a depth of about 32m. It is not known how far from the bottom the suction pipes ended, but dropping a string of cast iron pipe even a modest distance would cause the lower end to shatter.
