Murgatroyds Brine Pump

Notes on Camera Survey of Shaft 14 Dec 17

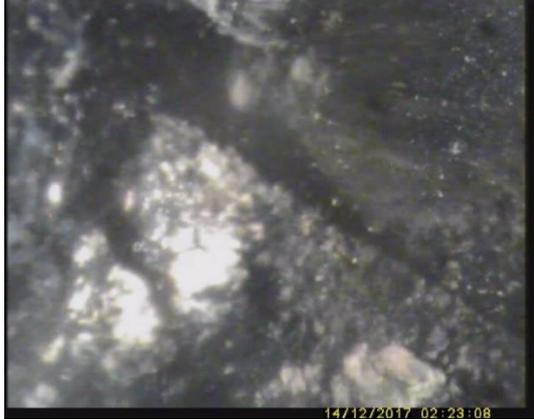
As suggested by the sonar survey, the shaft is blocked with rubble at a depth of approximately 60m from the surface. (estimated by measuring the length of suspension cable as the camera was withdrawn.) This rubble does not appear to originate from the shaft itself, some of it having the appearance of reinforced concrete, with one piece being fractured, clearly showing metal rods between the two sections.

<p>14/12/2017 02:23:08</p>	<p>Rubble at 60m level</p>

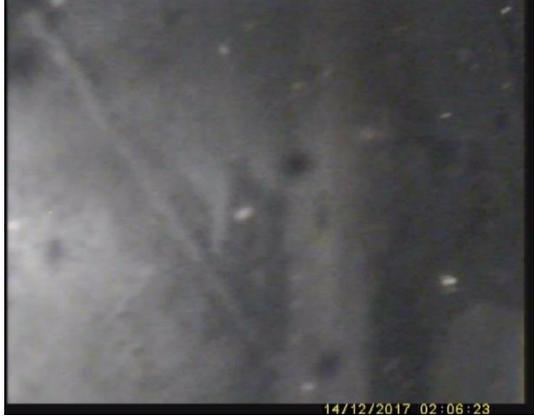
segments. The tie rods, which are intended to reinforce riser pipe joints, are missing, or hanging loose in several frames. Because the camera had no means of indicating the depth, it is not possible to accurately estimate the location of the damage. It does, however, appear to be worse near to the shaft blockage.

<p>14/12/2017 02:06:23</p>	<p>Riser pipe (background) with broken tie rod (diagonal)</p>

Because of the damage to the rising main, it will not be possible to restore the pumps to operational condition, or to recover the pump ends for display. During restoration of the headgear, it may be possible to recover some part of the pump rods for static display on the surface.

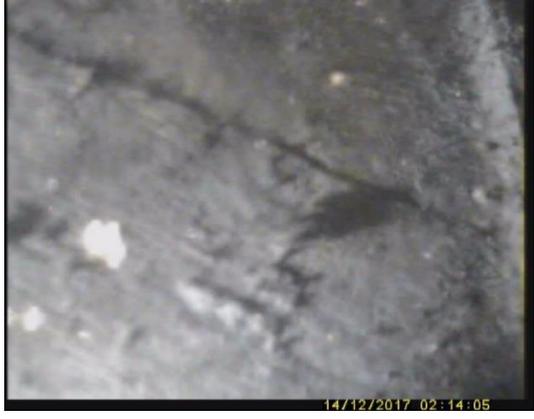
Apart from one place where the timber has been displaced about 50-100mm, the lining appears to be in good condition throughout.

<p>14/12/2017 02:14:05</p>	<p>Shaft lining boards</p>

It is not proposed to carry out any remedial work to the shaft, or its lining.

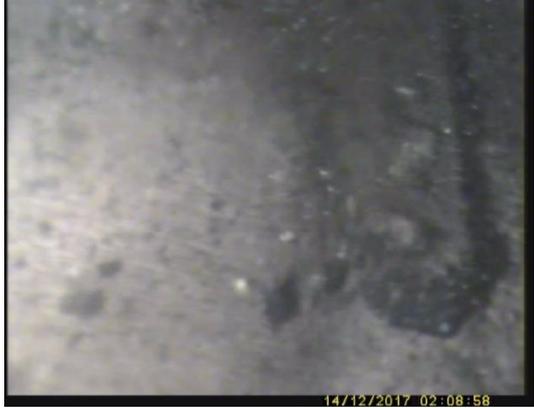
<p>14/12/2017 02:08:58</p>	<p>Iron cleat joining shaft lining boards</p>
