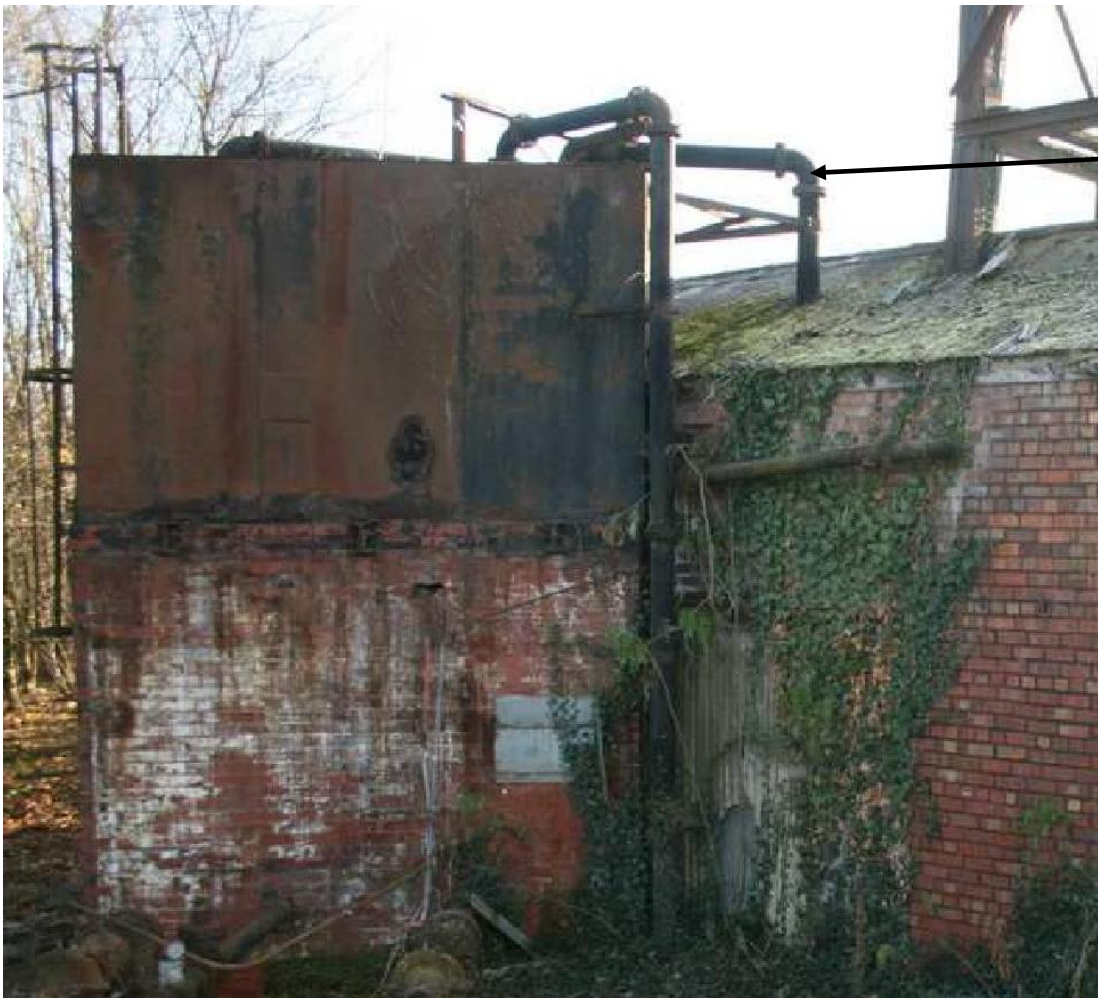
This image shows a pipe coming from the roof of the building. Support bracket gone as seen in the picture, still in place

All pipework and supports kept on site

Pipework removed from the height of the tank. End of pipe did go into the tank, this now needs to just rest up to it to give the illusion of going into the tank. There was a support bracket taken down. Not sure if pipe is in one or two pieces

Pipework removed from flange, this now is just propped up. End was again in the tank so we just need this to rest up to it. This is in two pieces.

Replacement ladder, with original positioning of brackets
