JAE/8903 31 March 2020

RE: <u>Murgatroyd's Brine Pump, Middlewich</u>

Further to your instructions Thomasons attended Murgatroyd's Brine Pump, Middlewich on 23 July 2019 in order to undertake a re-inspection of the building following removal of the gantry. We were also instructed to attend the steel fabricator's shop in Warrington where the removed gantry was being restored.

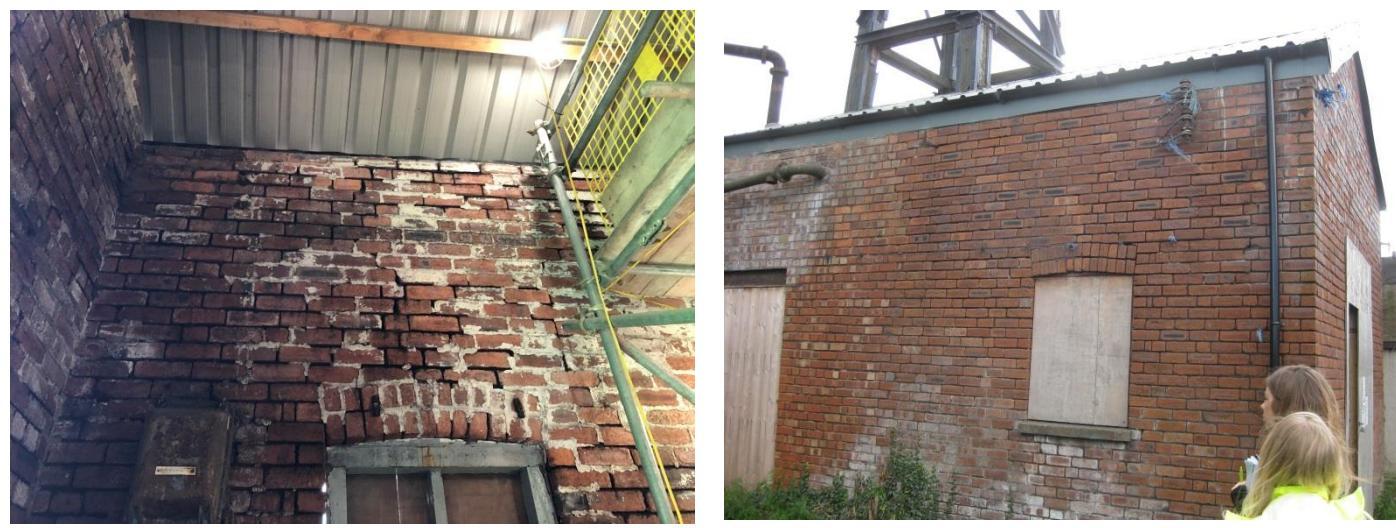
Cracking was noted above the front lefthand window inside the building but was not evident externally.

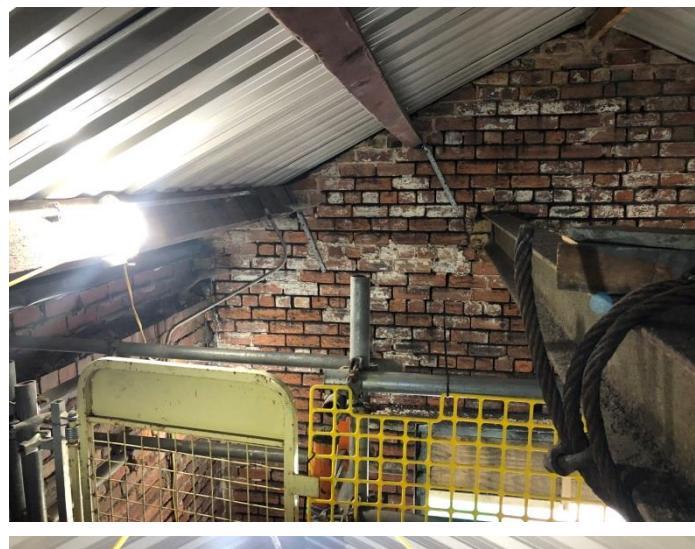
Deteriorated pointing in pike of front gable, no cracking noted externally.

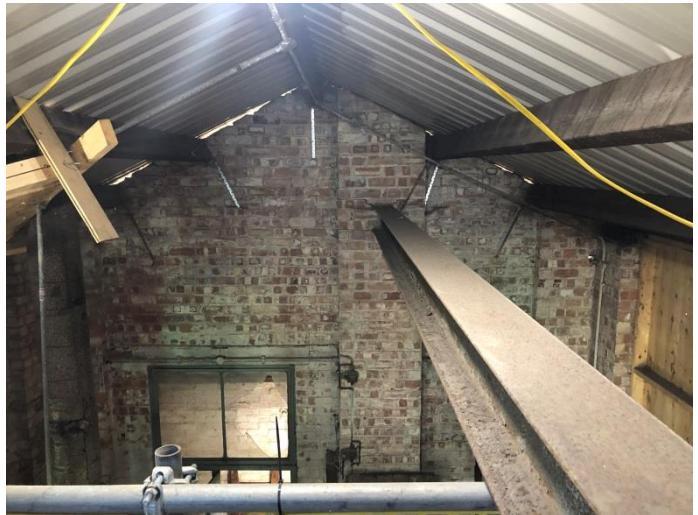
No significant structural defects in rear wall.

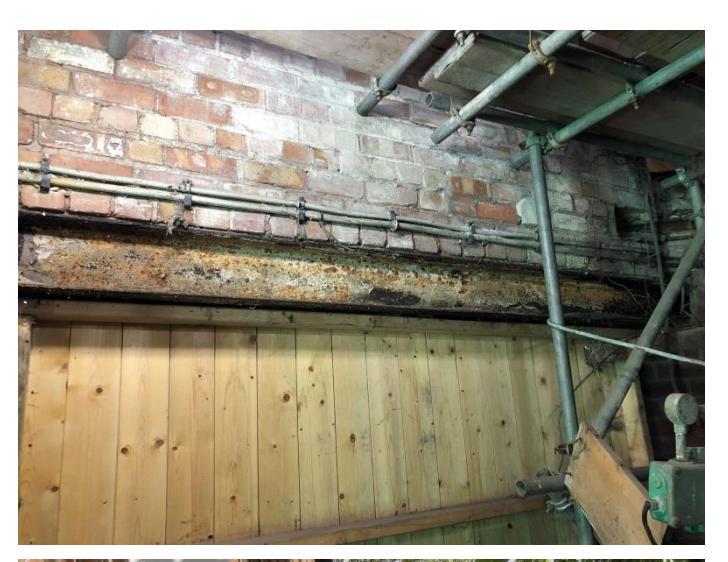
Corrosion of steel beam above opening in lefthand elevation.

The overall condition of the building housing Murgatroyd's Brine pump was in keeping with the time since work was last undertaken. Steel members that had not been adequately protected again corrosion exhibited extensive corrosion and the expansive forces resulting from this had caused cracking in the masonry walls.

Replacement and/or treatment of the steelwork has been sufficient to prevent ongoing corrosion and thus will also prevent further cracking from occurring relating to these members. It should be noted however that as the brine well remains open there may be a higher than normal salinity in the ambient atmosphere and hence regular inspection of the steelwork should be undertaken and any indications of corrosion should be treated promptly to prevent extensive future deterioration setting in.

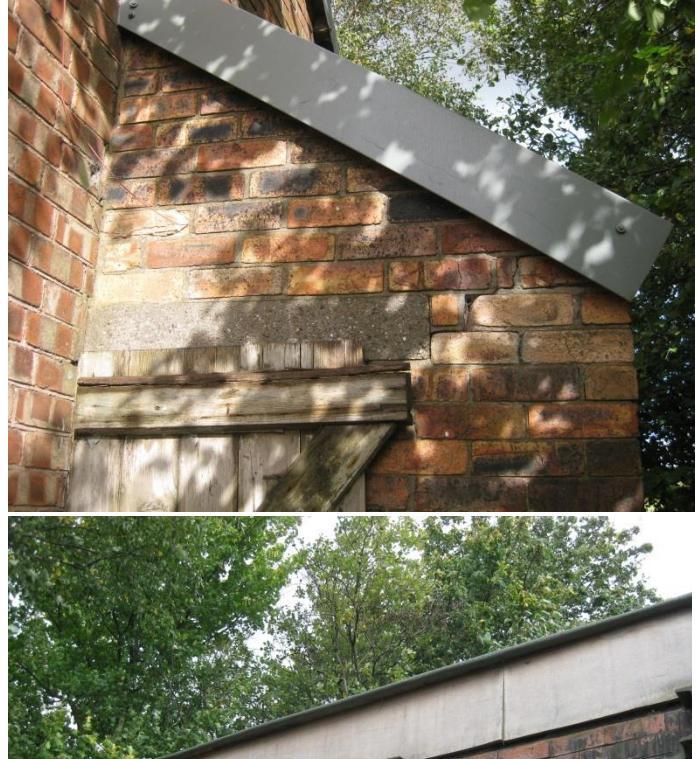
Cracking due to corroding lintel above pedestrian door at rear of building.

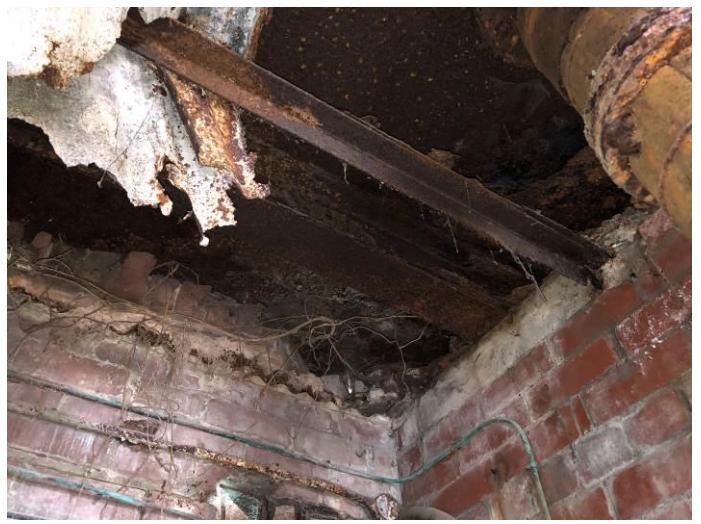
Severely corroded beam ends protruding through wall. Beams formerly supported the brine tank.

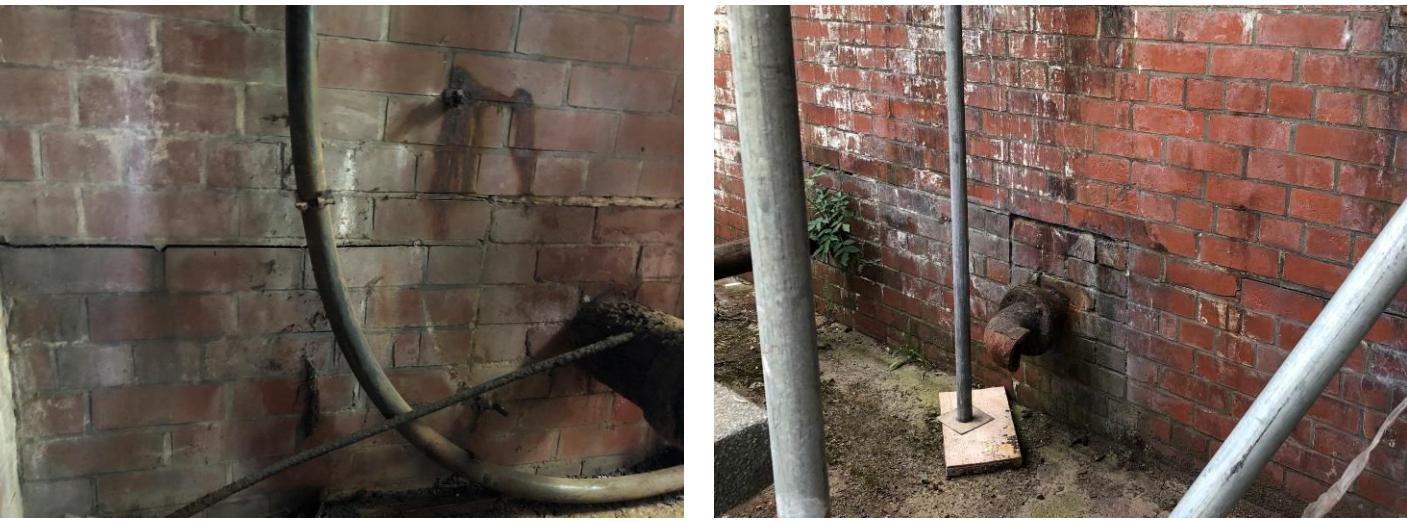
Internal and external cracking below brine tank resulting from corroding steelwork embedded within walls.

Cracking to the building and repointing works have been undertaken as part of the refurbishment works so the building is now considered to be a good structural condition.

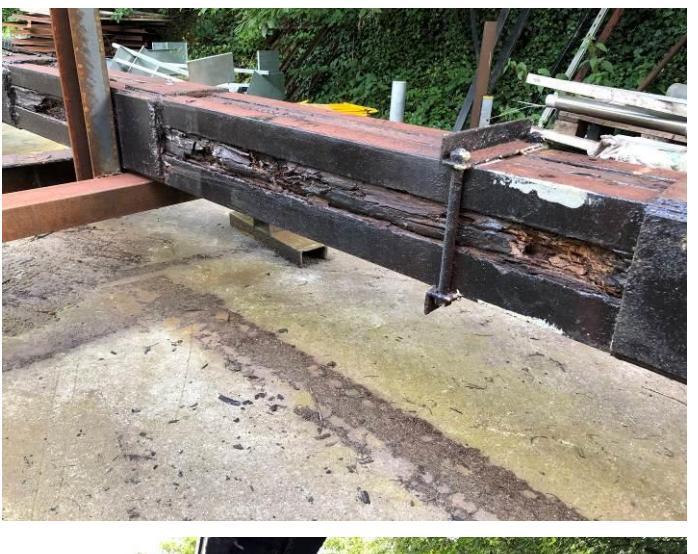
Rotten timber at approximately mid-height of the leg.

The majority of the steelwork of the gantry has been replaced. In agreement with Historic England the new steelwork and the reused steelwork has been galvanised in order to increase the longevity of the members. The timber frame of the gantry had suffered from extensive wet rot and has thus been replaced.

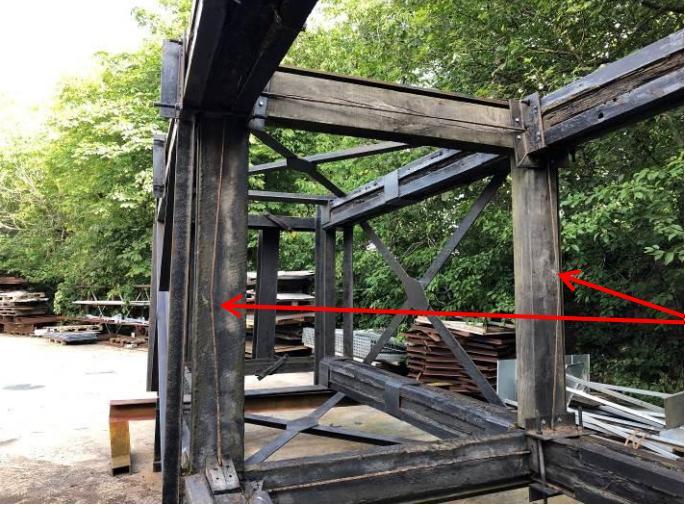
Bent / buckled tie rods.

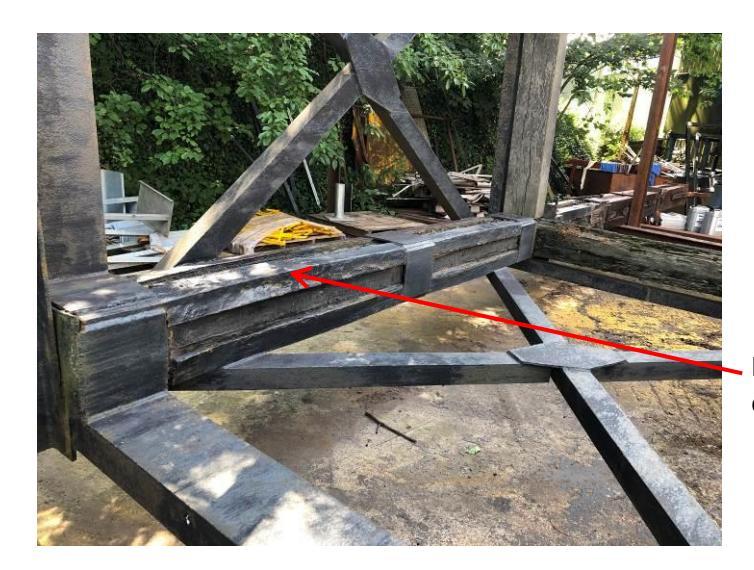
Distortion of steel member due to expansive forces of corrosion.
