# Site Visit Report

<b>Project Title</b>	Murgatroyd's Brine Pump Emergency Works	<b>Project No</b>	8402
<b>Client</b>	Middlewich Heritage Trust	<b>Date</b>	08.01.20
<b>Purpose</b>	Site Progress and Observations	<b>Visit By</b>	EG

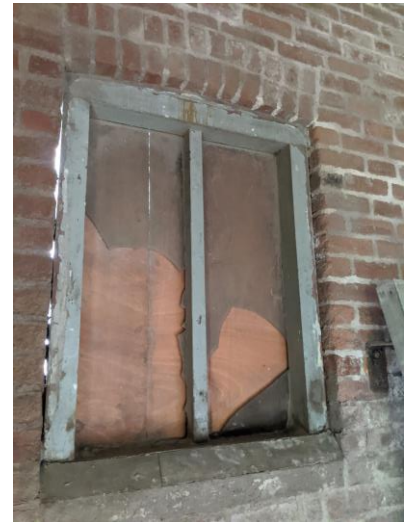
Figure 3 *Widows looked at externally*

**Figure 2/3 Scope of window and door replacement discussed on site with contractor and client**

Costs to be revised by Quadriga according to discussion
