Murgatroyd Pump Shaft Discussion of Observations from FLODIM Sonar Survey

The report was carried out by Flodim, on behalf of Robertson Geologging to assess the condition of the pump shaft at the Murgatroyd Pumping Station.

The visit took place on 8th March 2017

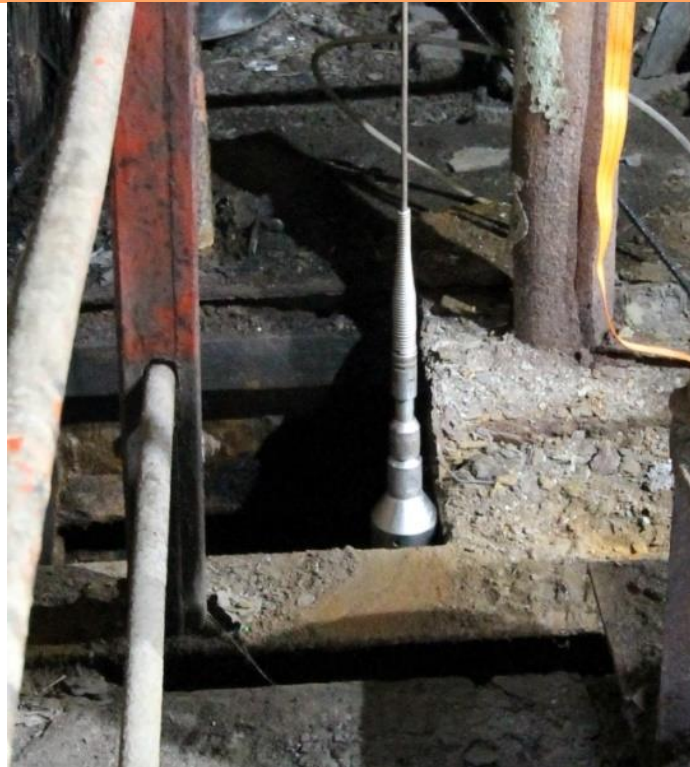
Figure 2 – Survey Datum (Probe datum is widest point of shoulder)

The survey datum was set at the level of the pump plinths within the pumphouse. (Fig 2)

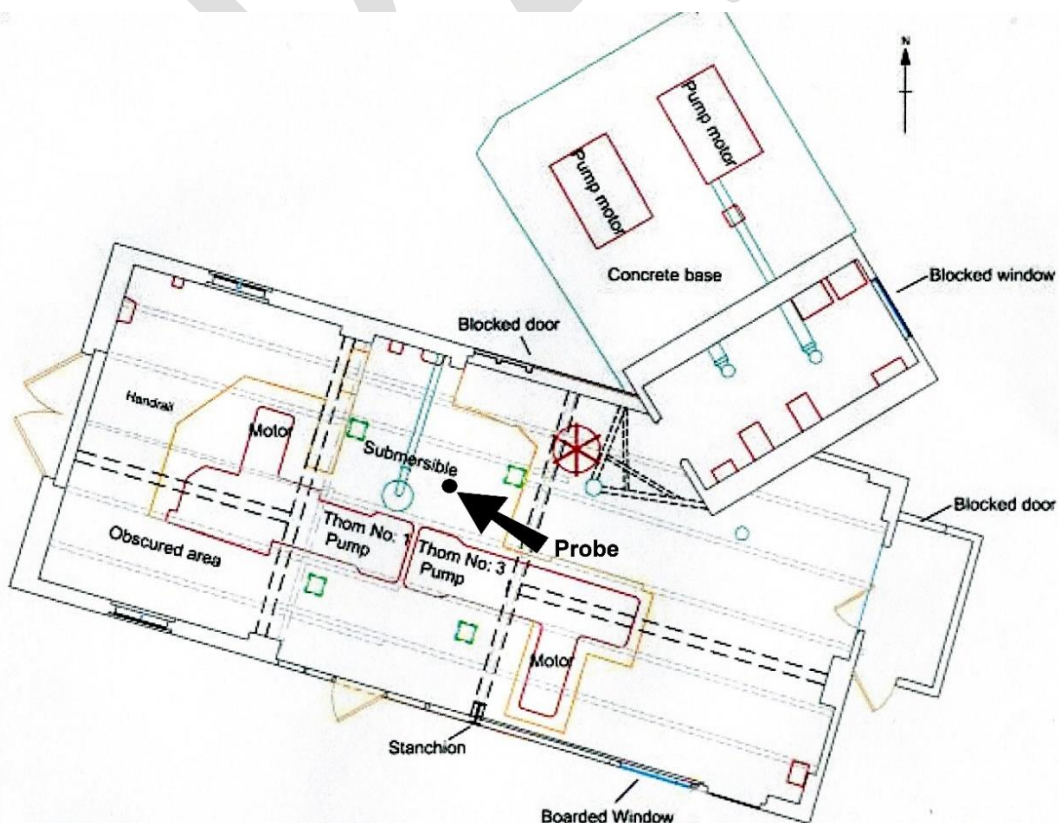
Figure 3– Plan View of Pump House, showing location of survey probe

Access to the shaft was limited to a small inspection hatch between the two main pump support steels, North of Pump No3 and East of the Submersible pump.

The exact location of the probe is indicated on the Plan view (Figure 3).

Shaft sections derived from by the survey are centred on the probe.
