Murgatroyd Pump Shaft Discussion of Observations from FLODIM Sonar Survey

The report was carried out by Flodim, on behalf of Robertson Geologging to assess the condition of the pump shaft at the Murgatroyd Pumping Station.

The visit took place on 8th March 2017

Report No 17-3022

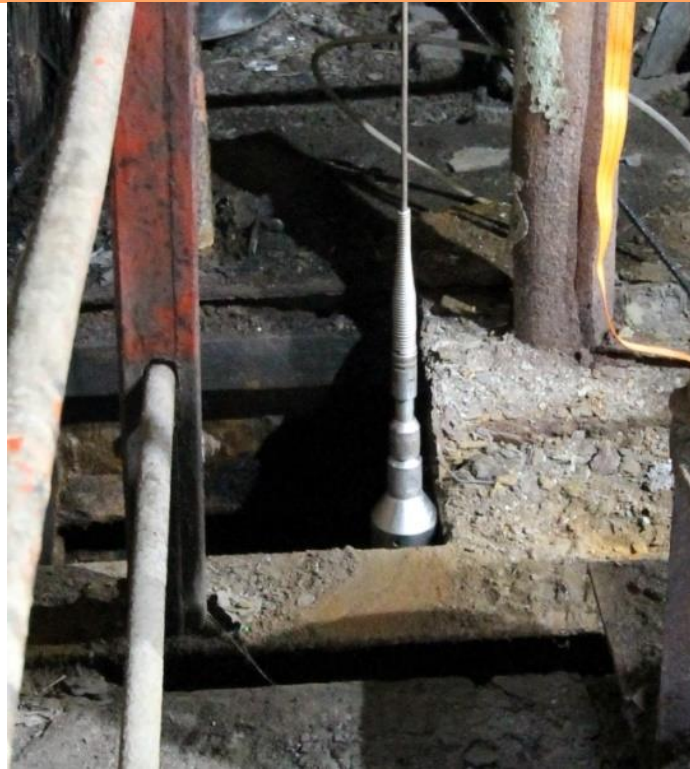
Figure 2 – Survey Datum (Probe datum is widest point of shoulder)

The survey datum was set at the level of the pump plinths within the pumphouse. (Fig 2)

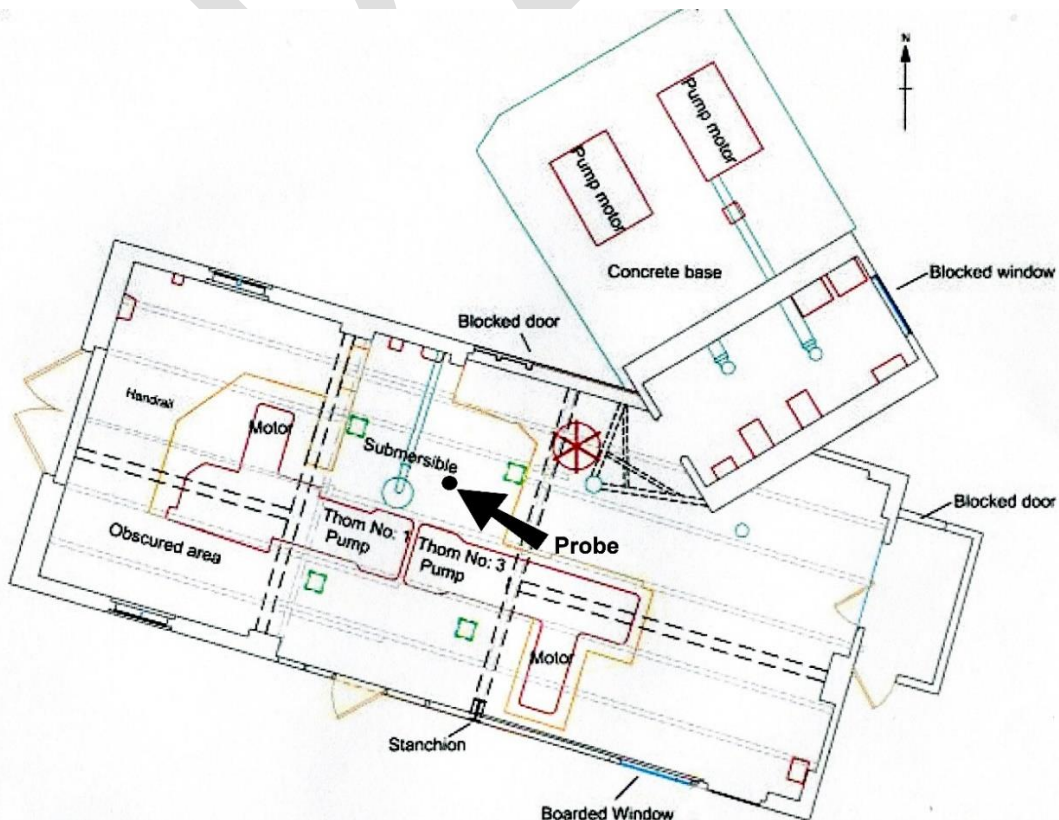
Figure 3– Plan View of Pump House, showing location of survey probe

Access to the shaft was limited to a small inspection hatch between the two main pump support steels, North of Pump No3 and East of the Submersible pump.

The exact location of the probe is indicated on the Plan view (Figure 3).

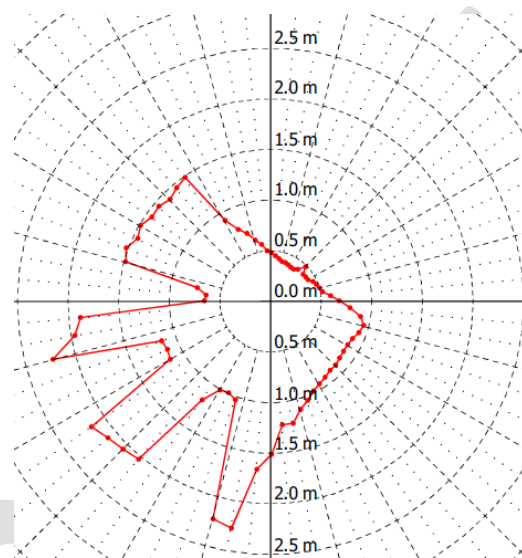
Figure 5 – Typical horizontal section

The probe is located at the zero point in the centre of the chart. North is at the top.

The three indents are the pump delivery pipes running vertically up the shaft. Clearly, if the sonar signal is reflected by the pipe, it is prevented from reaching the shaft wall behind the pipe. This causes a series of acoustic “shadows” behind the pipes, where no detail can be detected.
