Revealing Murgatroyd's Project

PROGRESS REPORT PHOTOGRAPHS

Contained in this report is the photographic evidence of works being carried out at Murgatroyd's Brine Pumps as part of the Revealing Murgatroyd's Project. Appendix 13.

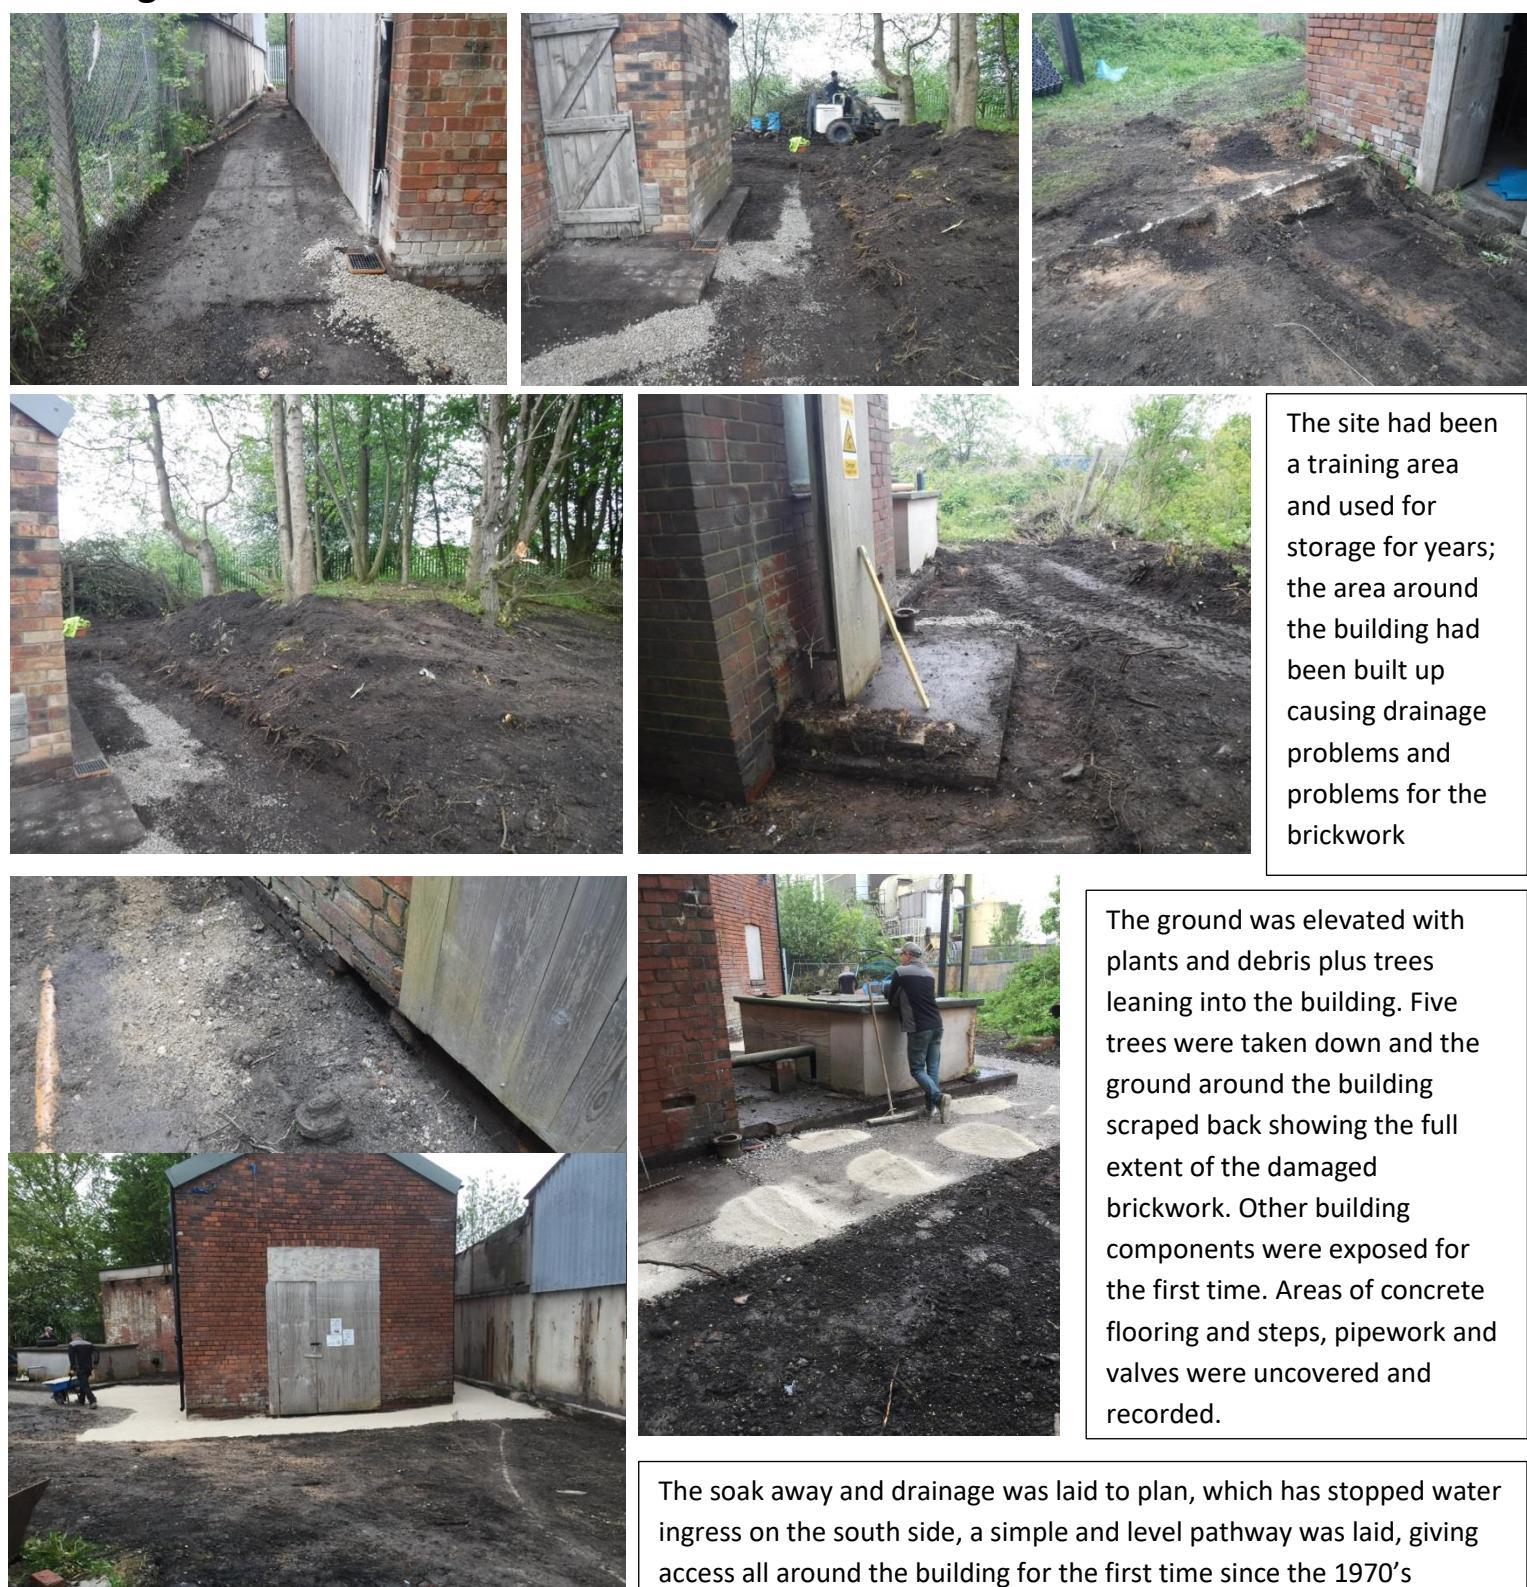
Murgatroyd's Brine pump Stage 1 Ground Works

The flooding damage to the building can be clearly seen in the state of the brickwork at the base, we still have drainage issues on the North side at this point as the water is coming off the bunds and debris on the North-North-East side of the site. These issues are dealt with when the north side landscaping plan was carried out and we were able to start the habitats plan.

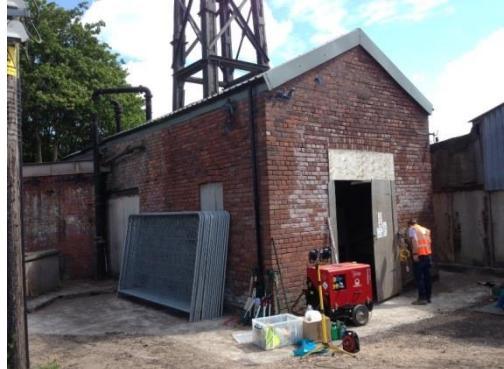
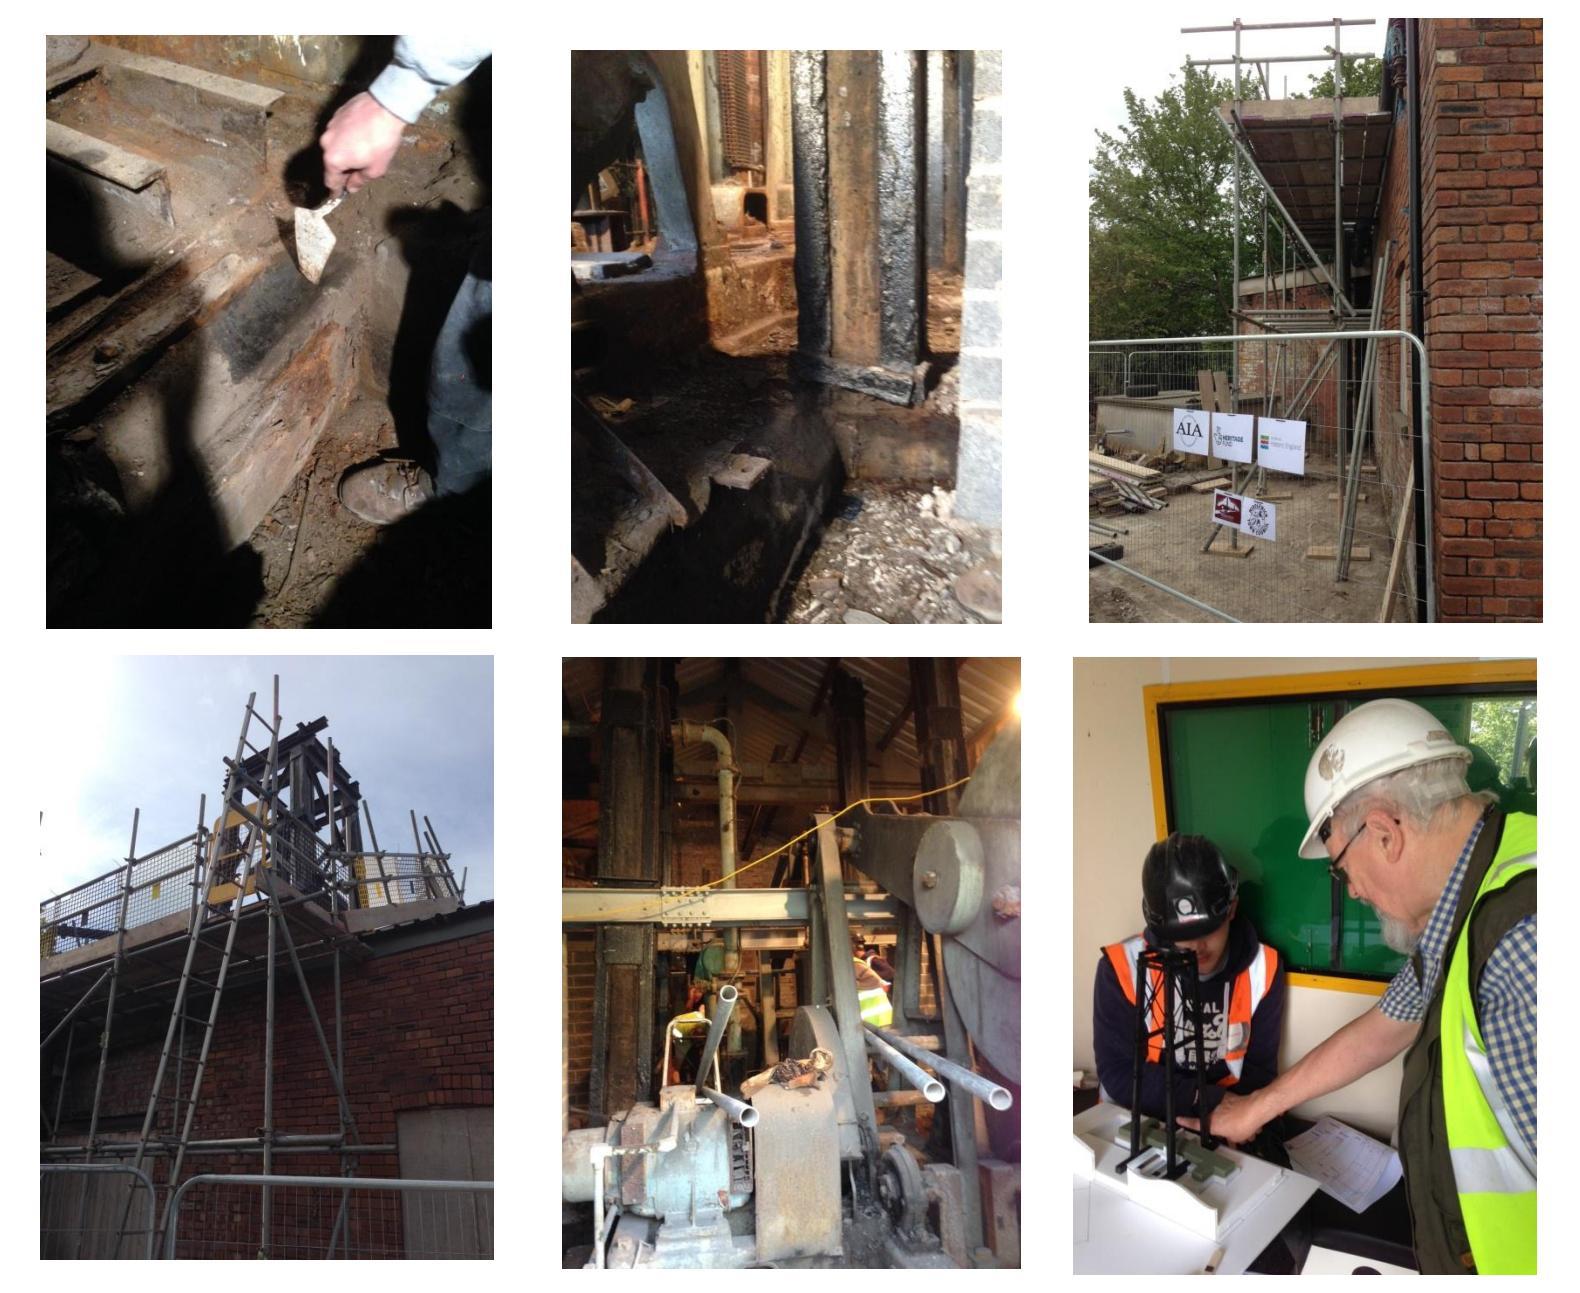
Murgatroyd's Brine pump Preparation and Inspection Week

Scaffold was erected and the gantry and building inspected. The initial inspections allow the gantry plan to be finalised. Our volunteer who is a professional pump engineer discusses the various issues around lifting the gantry and what we should expect underneath regarding the supports. Steve is meeting with timber expert Luke illustrating his points using a 3D model he made.

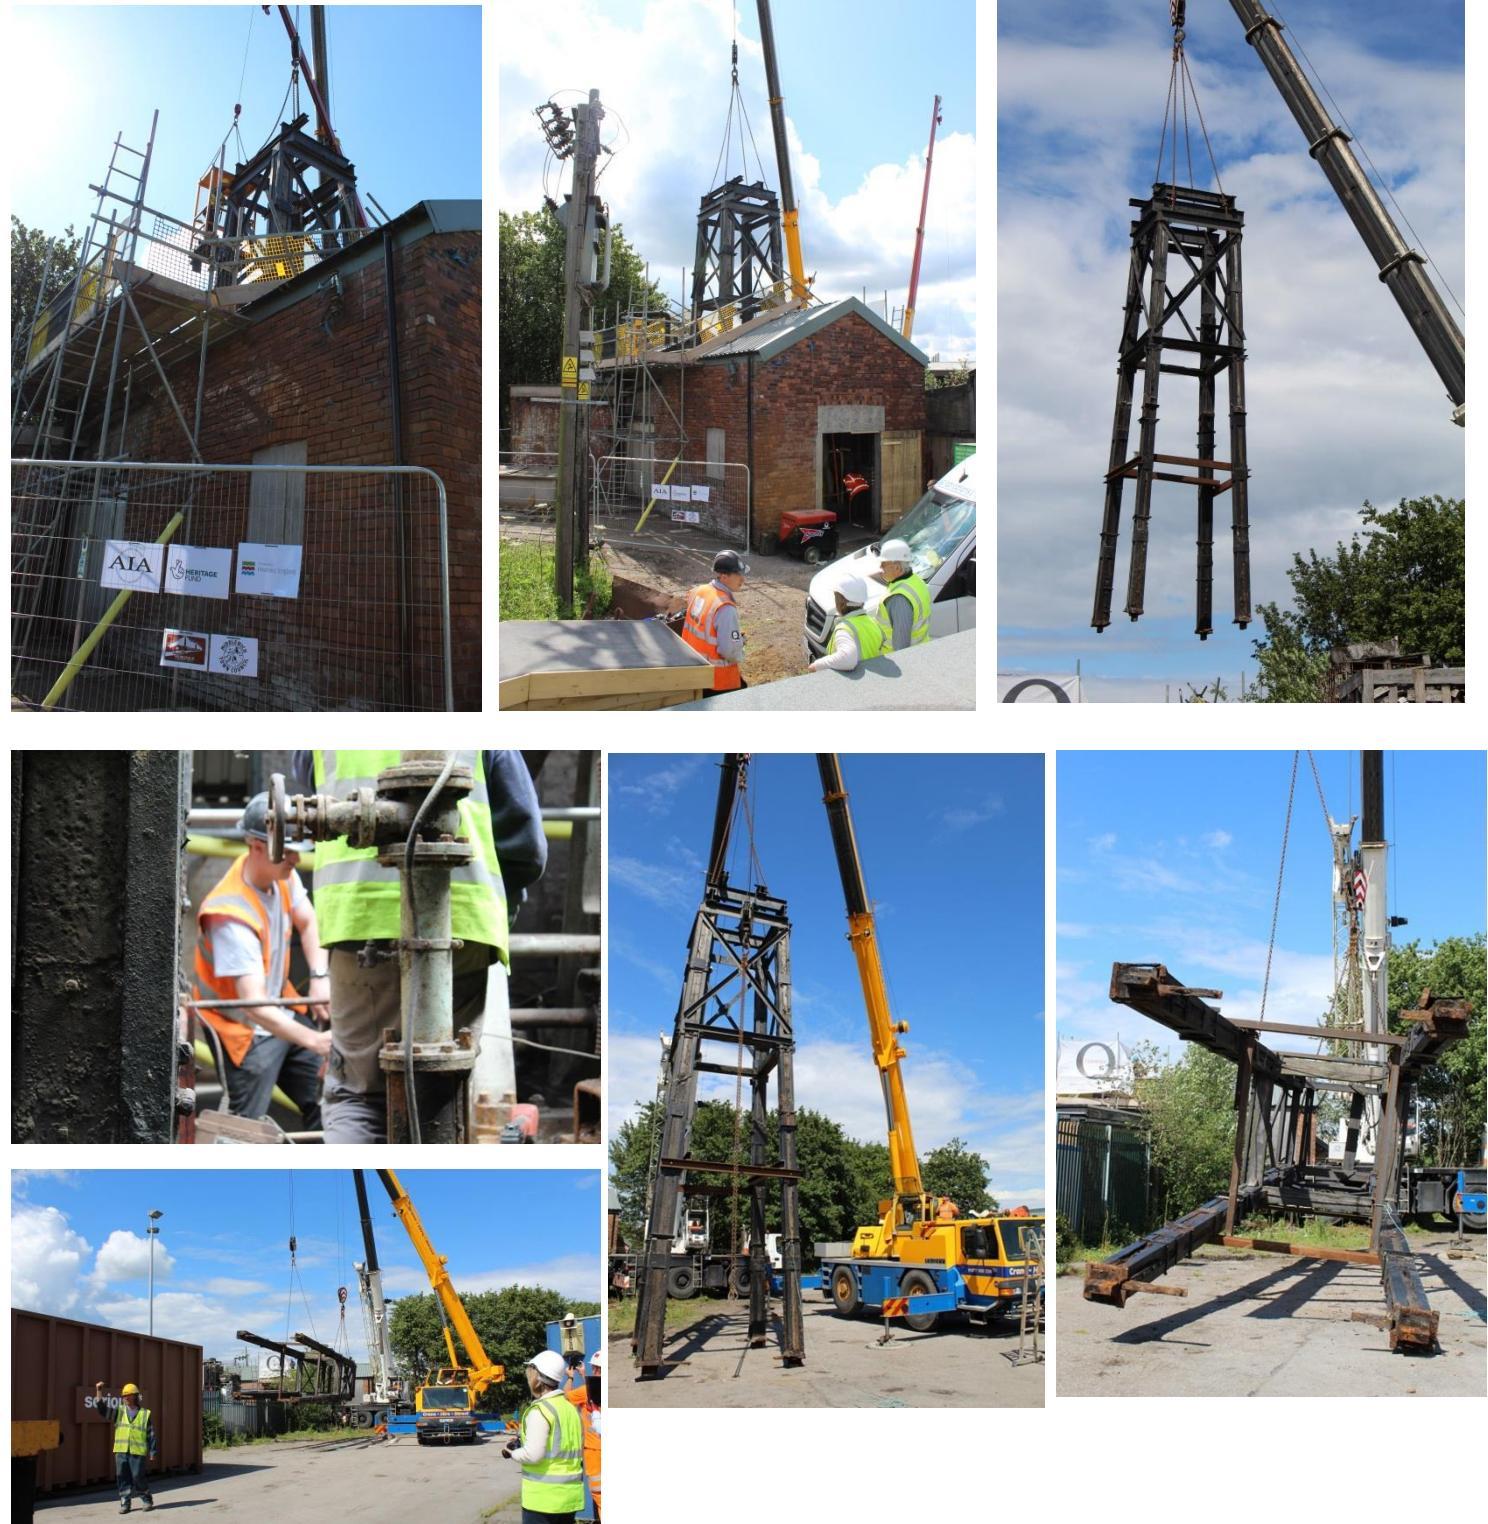
Murgatroyd's Brine pump Removal of Gantry

Key volunteers were involved in the lifting of the gantry, the roof was removed and the gantry supported ready for two large cranes to take out the gantry from its supporting timbers and laid the structure flat ready for transportation. The whole process was monitored by three volunteers from different angles, as well as photographs inside the building showing before and after. For the first time we all get a close up view of the structure and the methods used build the gantry and its supports.

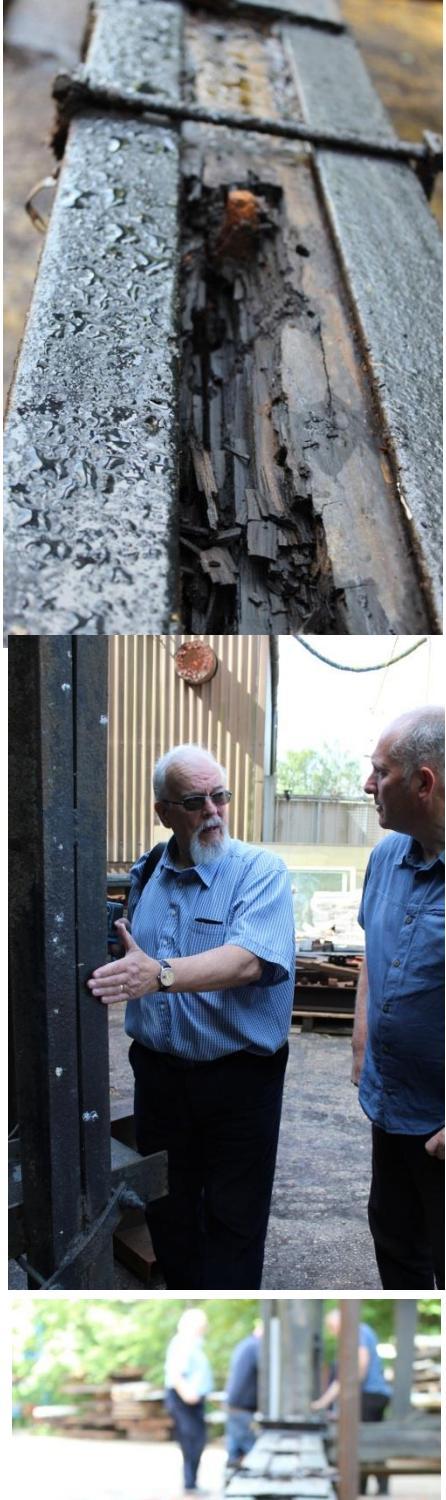
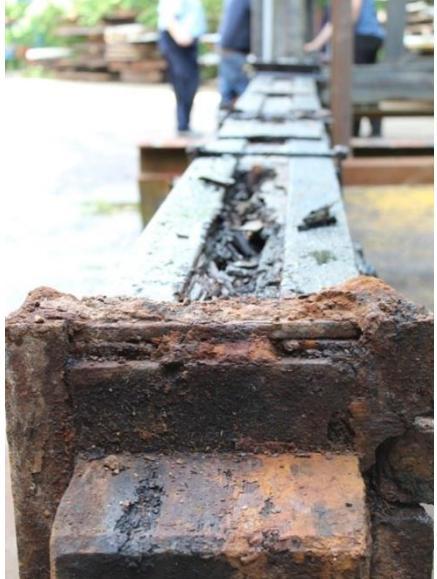
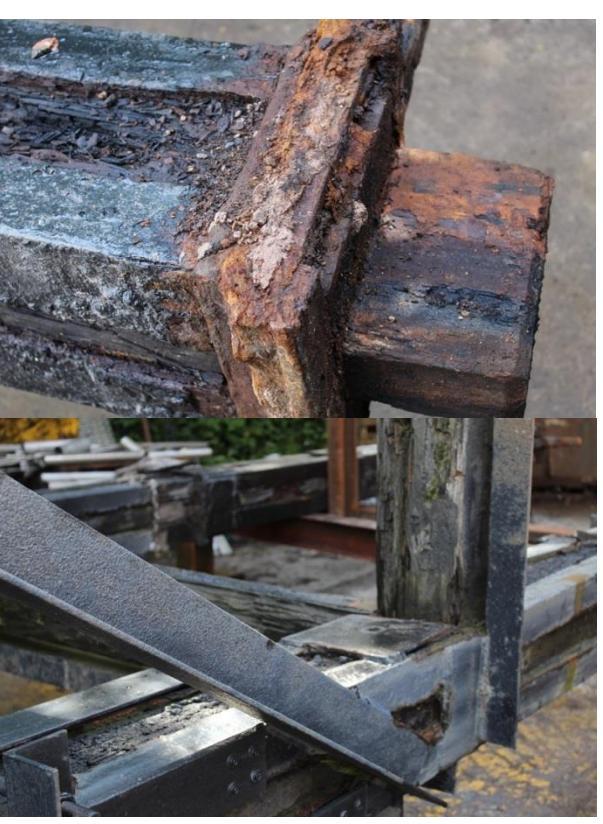
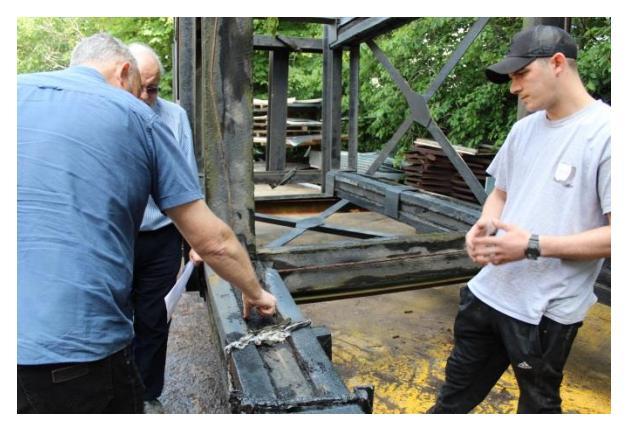
Murgatroyd's Brine pump Gantry Repairs

The inspection of the gantry shows that the timber is mostly rotten all the way through which isn't surprising as it was built in 1889. An inspection and meeting took place with our volunteer engineer, Historic England and the timber specialist to decide the best way to proceed. Steve's plan and drawings were sent to the structural engineer to draw up and produce an architect's instruction.

The plan consists of using salvaged timber like for like to replace the damaged timber, some timber and metal supports were re-used where possible. The original legs are back for display at the site so we can retain them.

Parts of the steels can be salvaged from the gantry, agreement as to how the timber is to be spliced together was approved. The replacement timber has been cut identically.

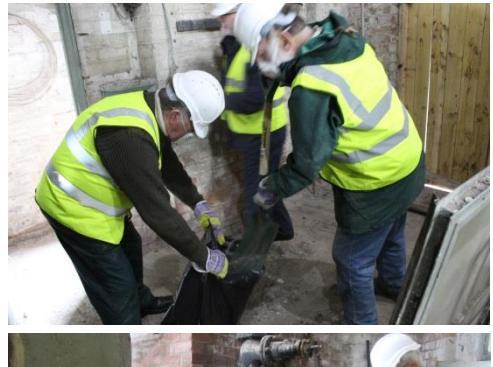
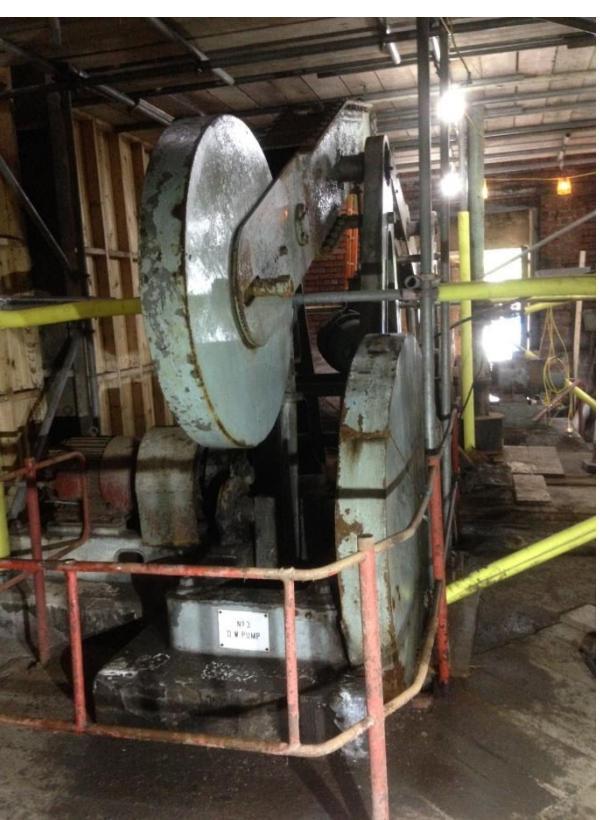
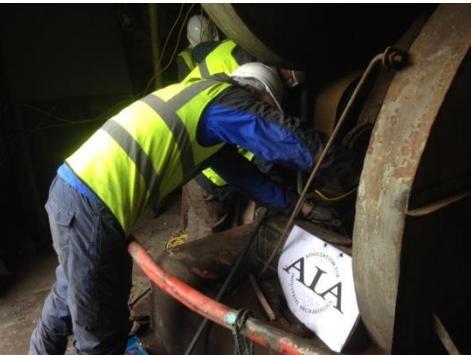
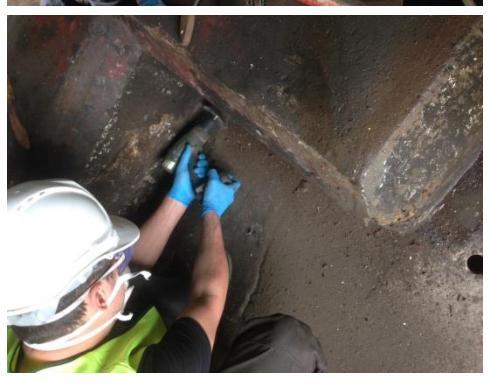
Murgatroyd's Brine pump Clean-up of Pump House and Equipment

Image of the pump house during its deep clean, showing the materials used, construction, line of the pipework and paint colours

The biggest part of the project is cleaning up the site and working on the historical elements of the brine pumps and equipment. Photos show the clear out the buttress supports that held the gantry, clearing all debris from the floor, timbers, plinths, steels and wall mounted equipment. Lots of dirt, dust, corrosion and grease to be dealt with. We uncovered damaged timbers throughout the building, uncovered oil tanks and came across writing on the pumps themselves. Taken paint samples from all of the elements, including the plinth which we didn't know was painted, uncovered the base paint of the pumps. The floor is not as damaged as first thought; only five areas need timber replacements

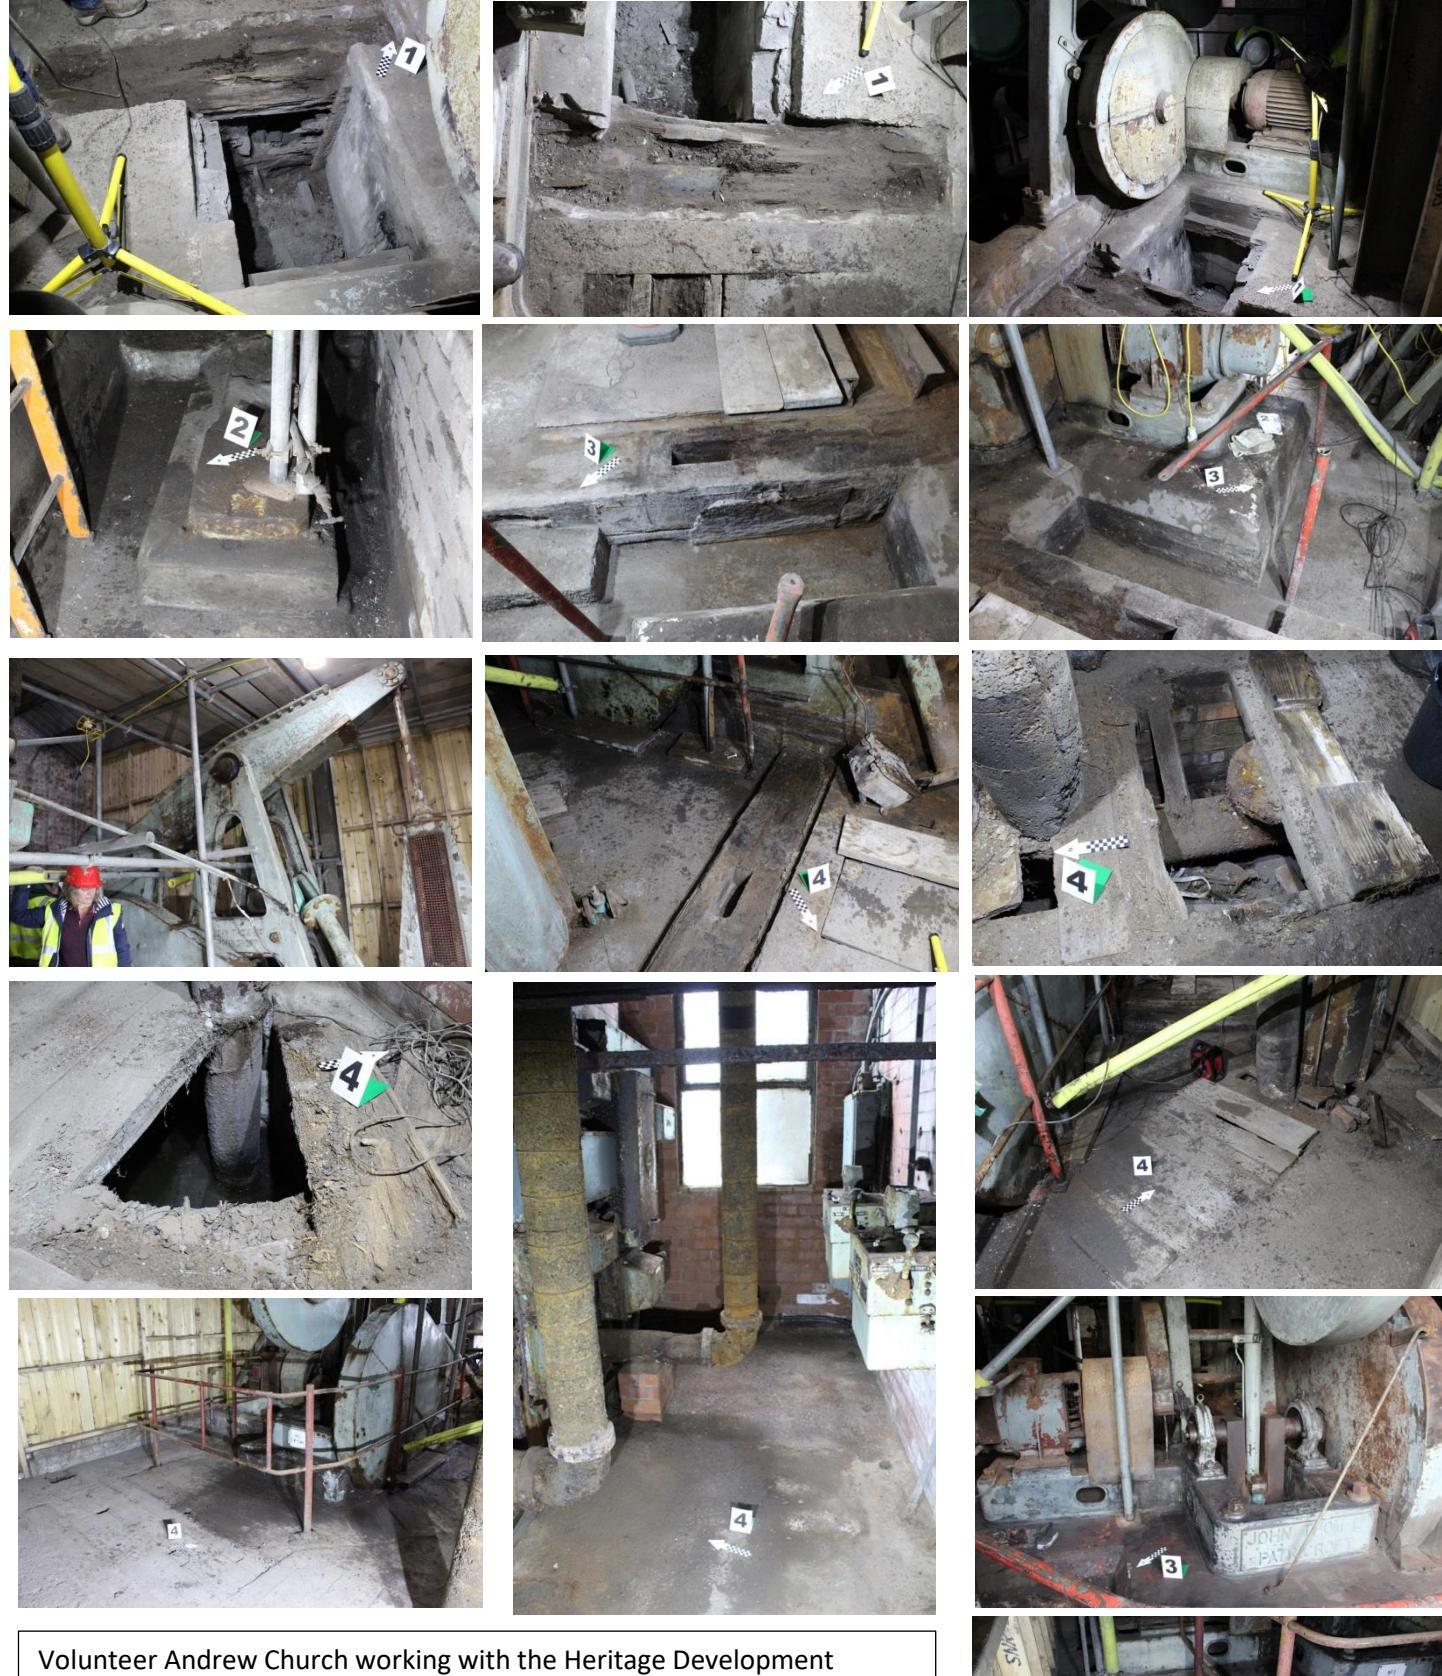
Murgatroyd's Brine pump Watching brief

Volunteer Andrew Church working with the Heritage Development Officer and our pump engineer has been carrying out the watching brief, above are some of the documentary photographs taken of the site separating the building into four main areas. Each area is photographed and measured and compared to the original drawings, which shows some variation. The new findings will be written up as an update to the original building survey carried out in 2011.

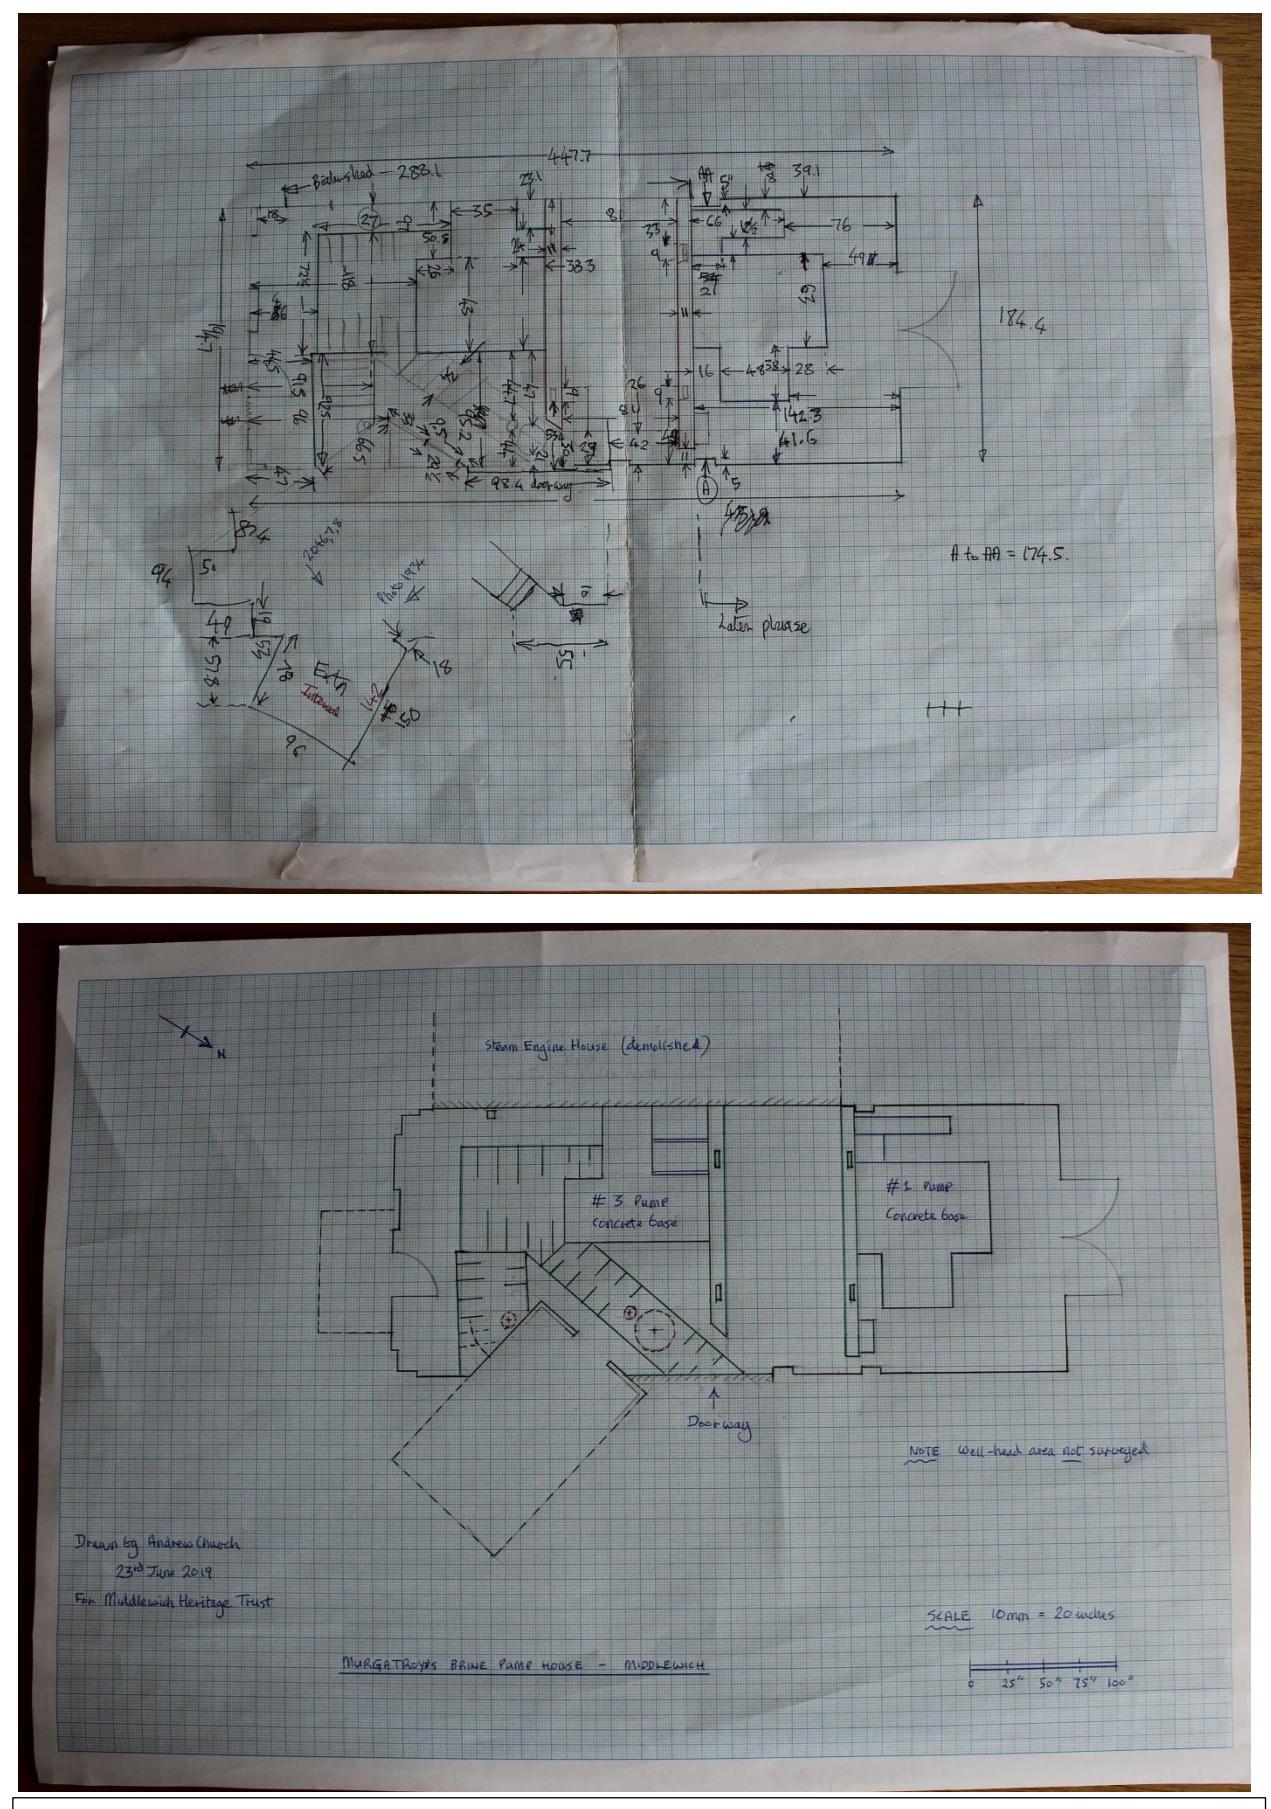
Murgatroyd's Brine pump Watching brief

Updated measurements of the brine pump building as it exists today, this work is to be drawn up as a technical illustration and published online.

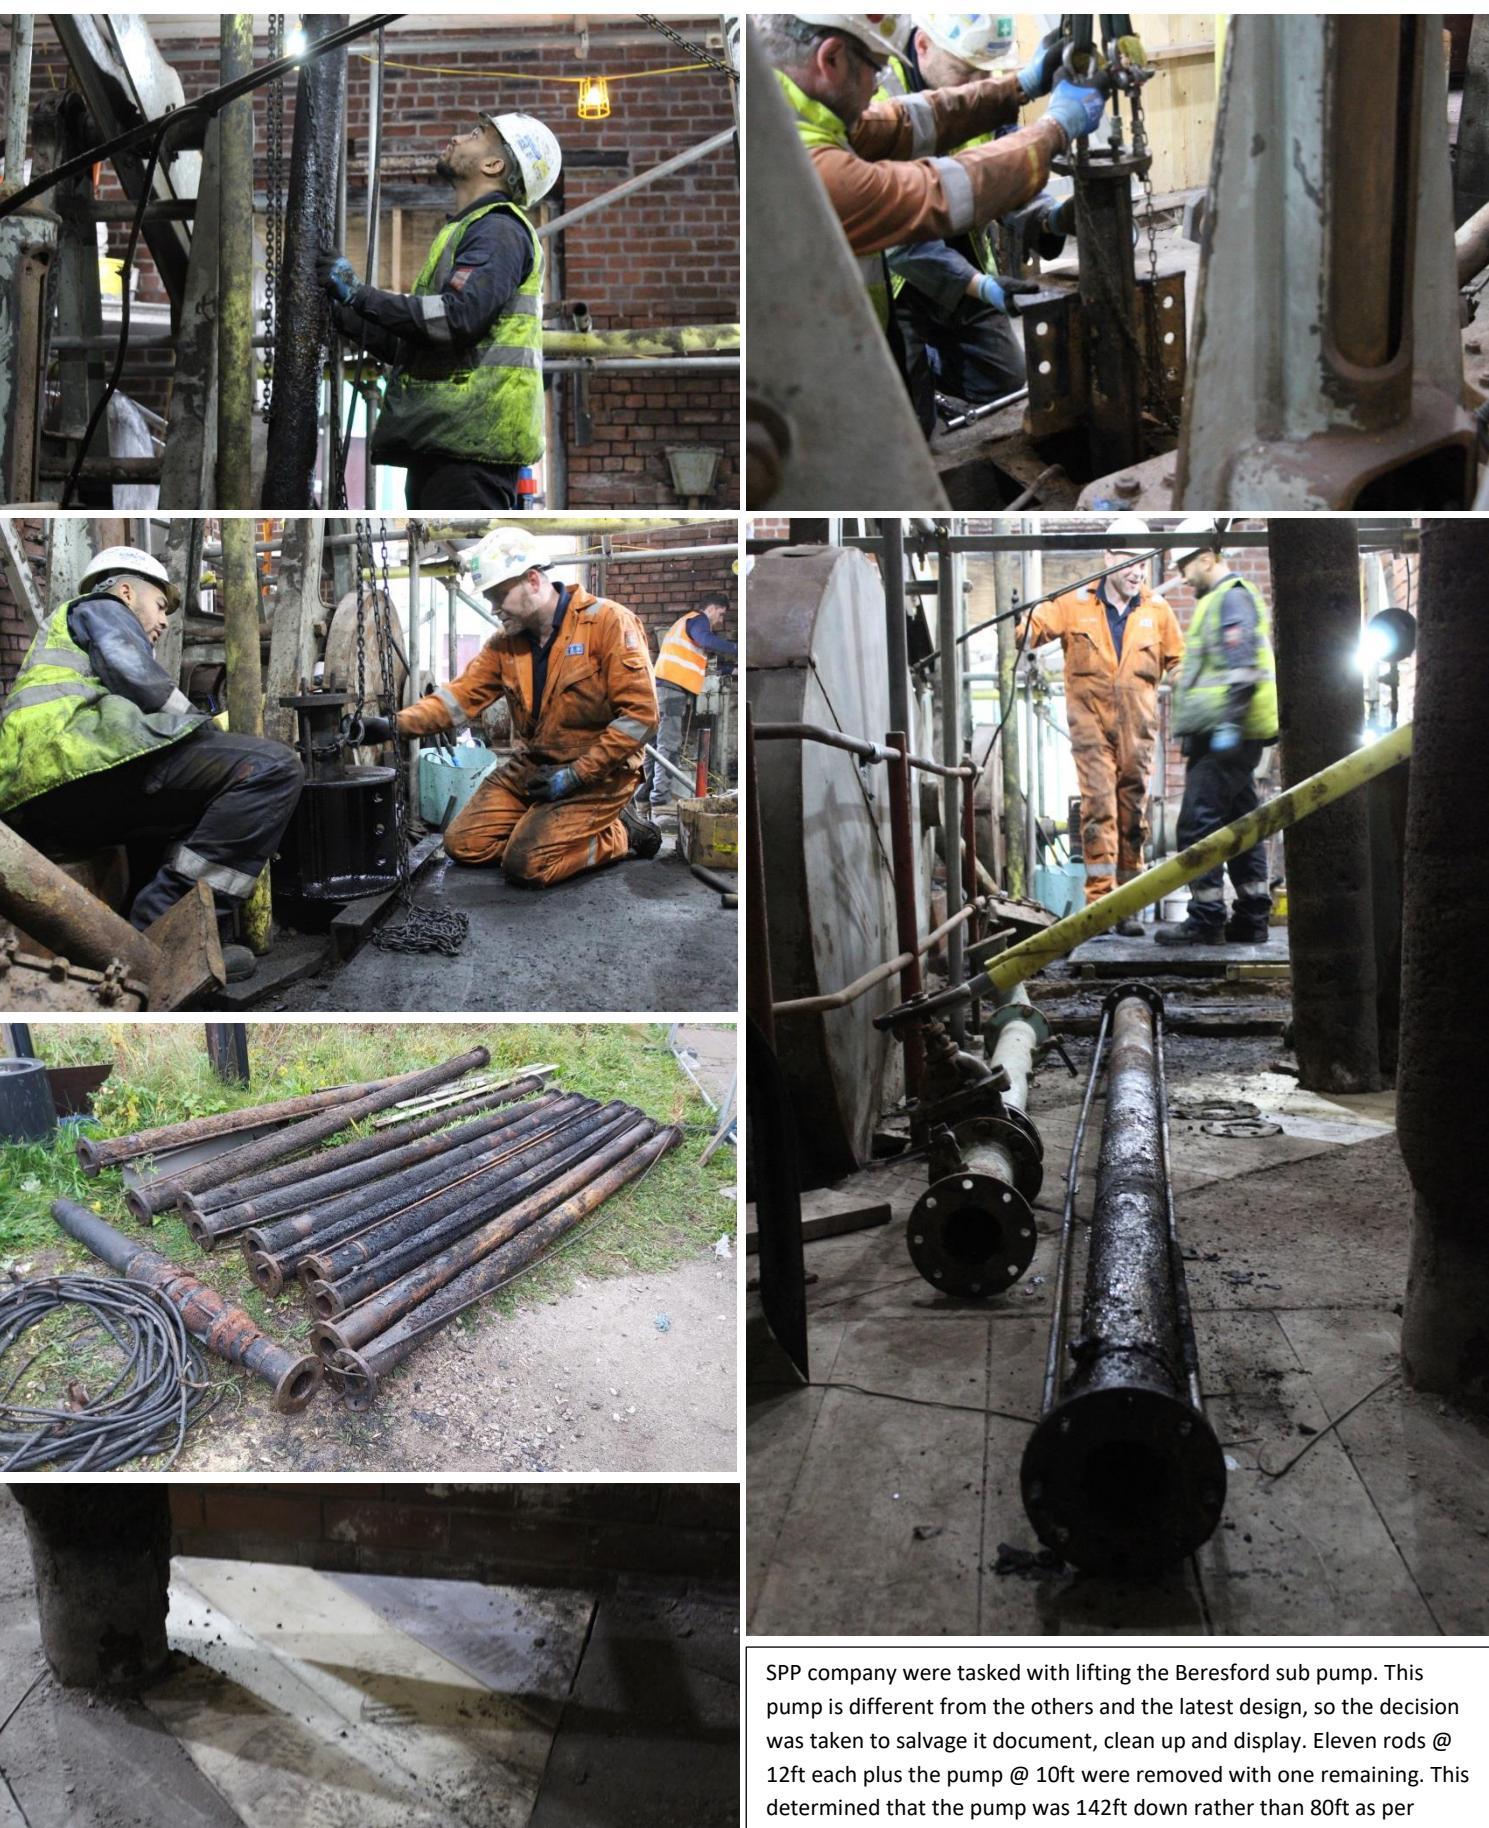
Murgatroyd's Brine pump Removal of the Breresford sub pump for display, document.

documents. The company brought one of their apprentices along to help with the lift, the base clamp was galvanized and painted.

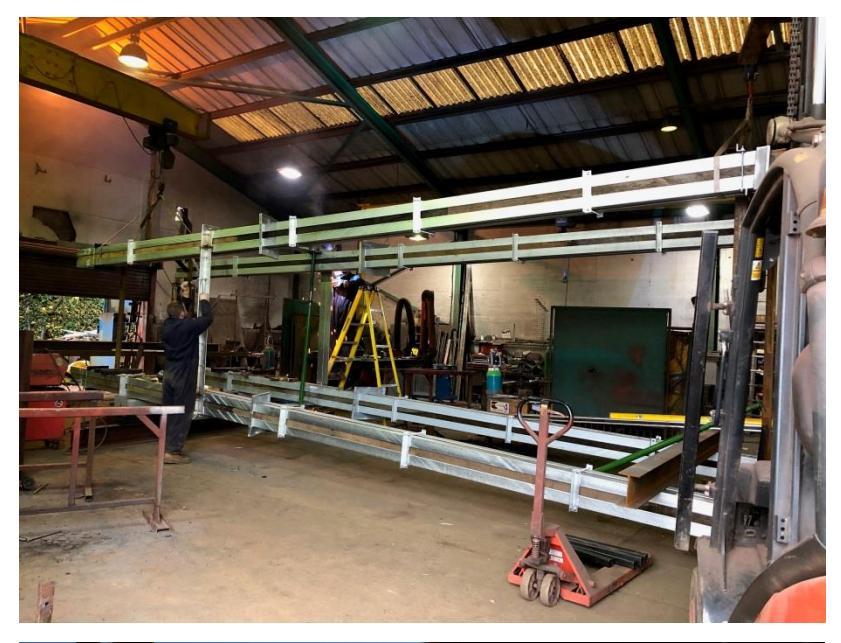
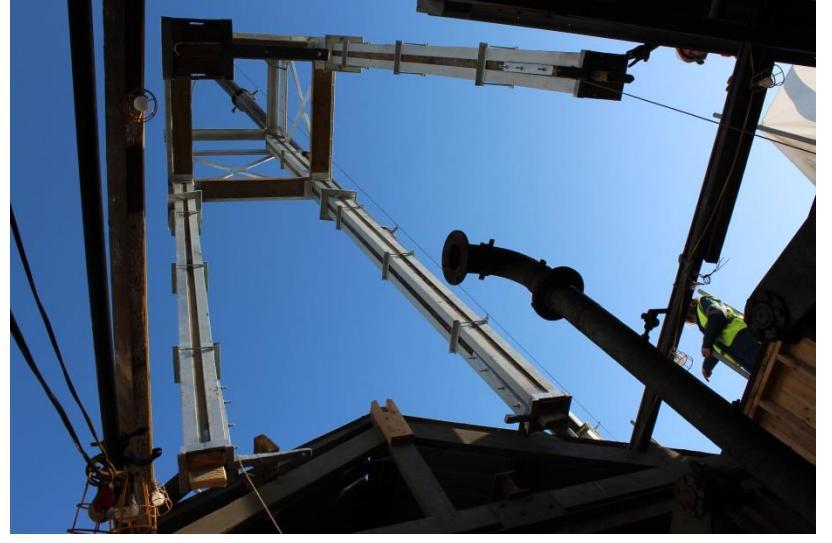
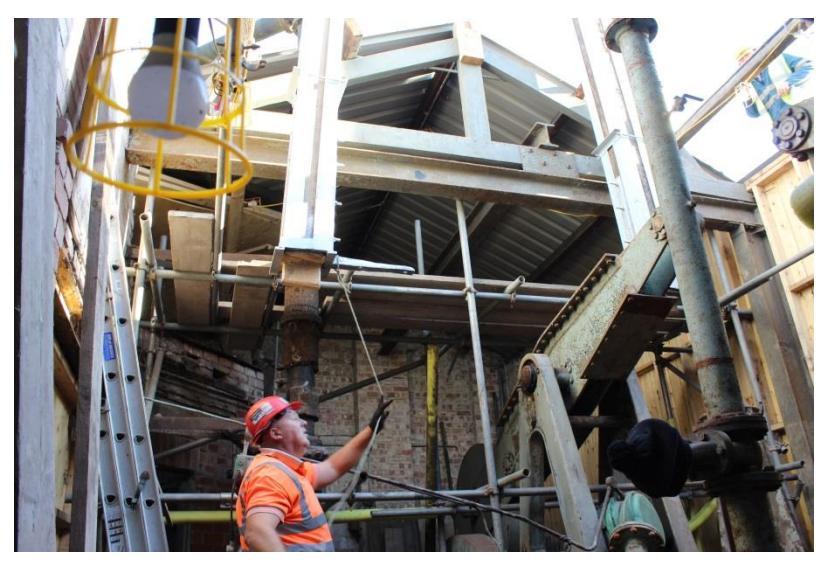
Murgatroyd's Brine pump Gantry fabricated and galvanised

The new gantry, shot-blasted, galvanised and fabricated using as much of the old gantry parts as possible. New supporting timbers were made around the well head on the west side while the east timbers are re-used, the gantry legs slot back into place.

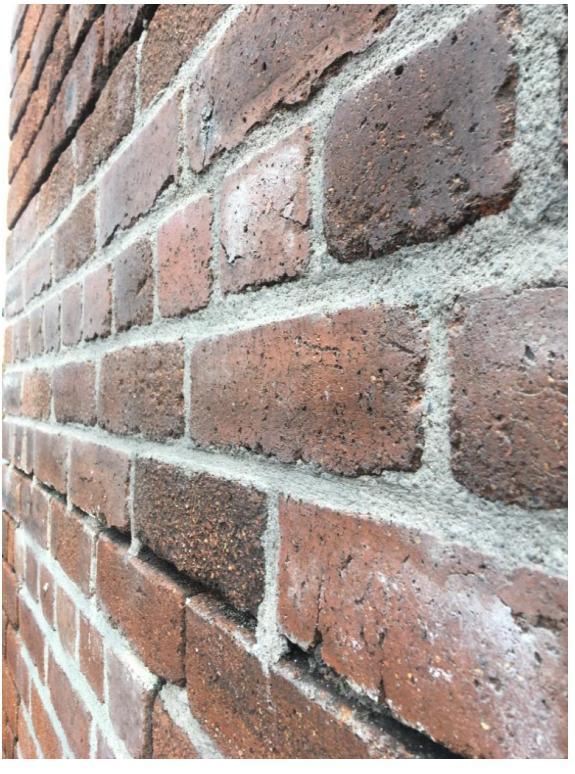
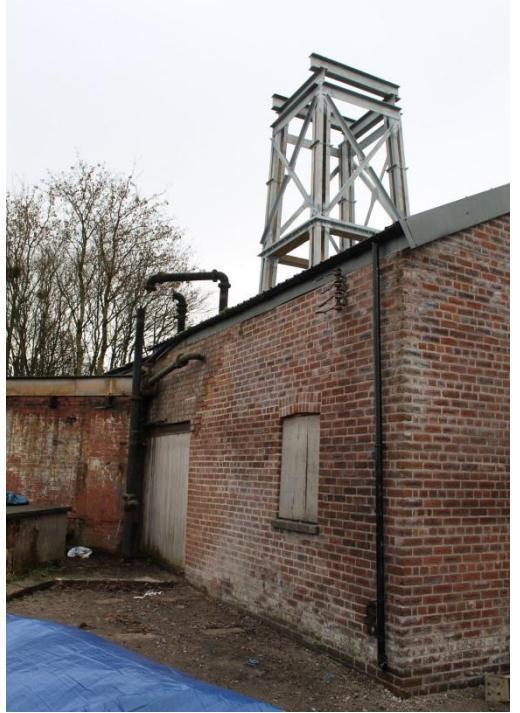
Murgatroyd's Brine pump Works to the roof and brickwork surrounding the gantry

Special lime mortar mix and application to the damaged 1930's brickwork, approved by Historic England. Improving the strength of the brickwork around the roof line, at the foot of the wall and around the windows.

The interior brickwork is whitewashed with an agreed lime mix as it once was.

Once the windows are in all timber cladding will be painted by the volunteers to protect it.

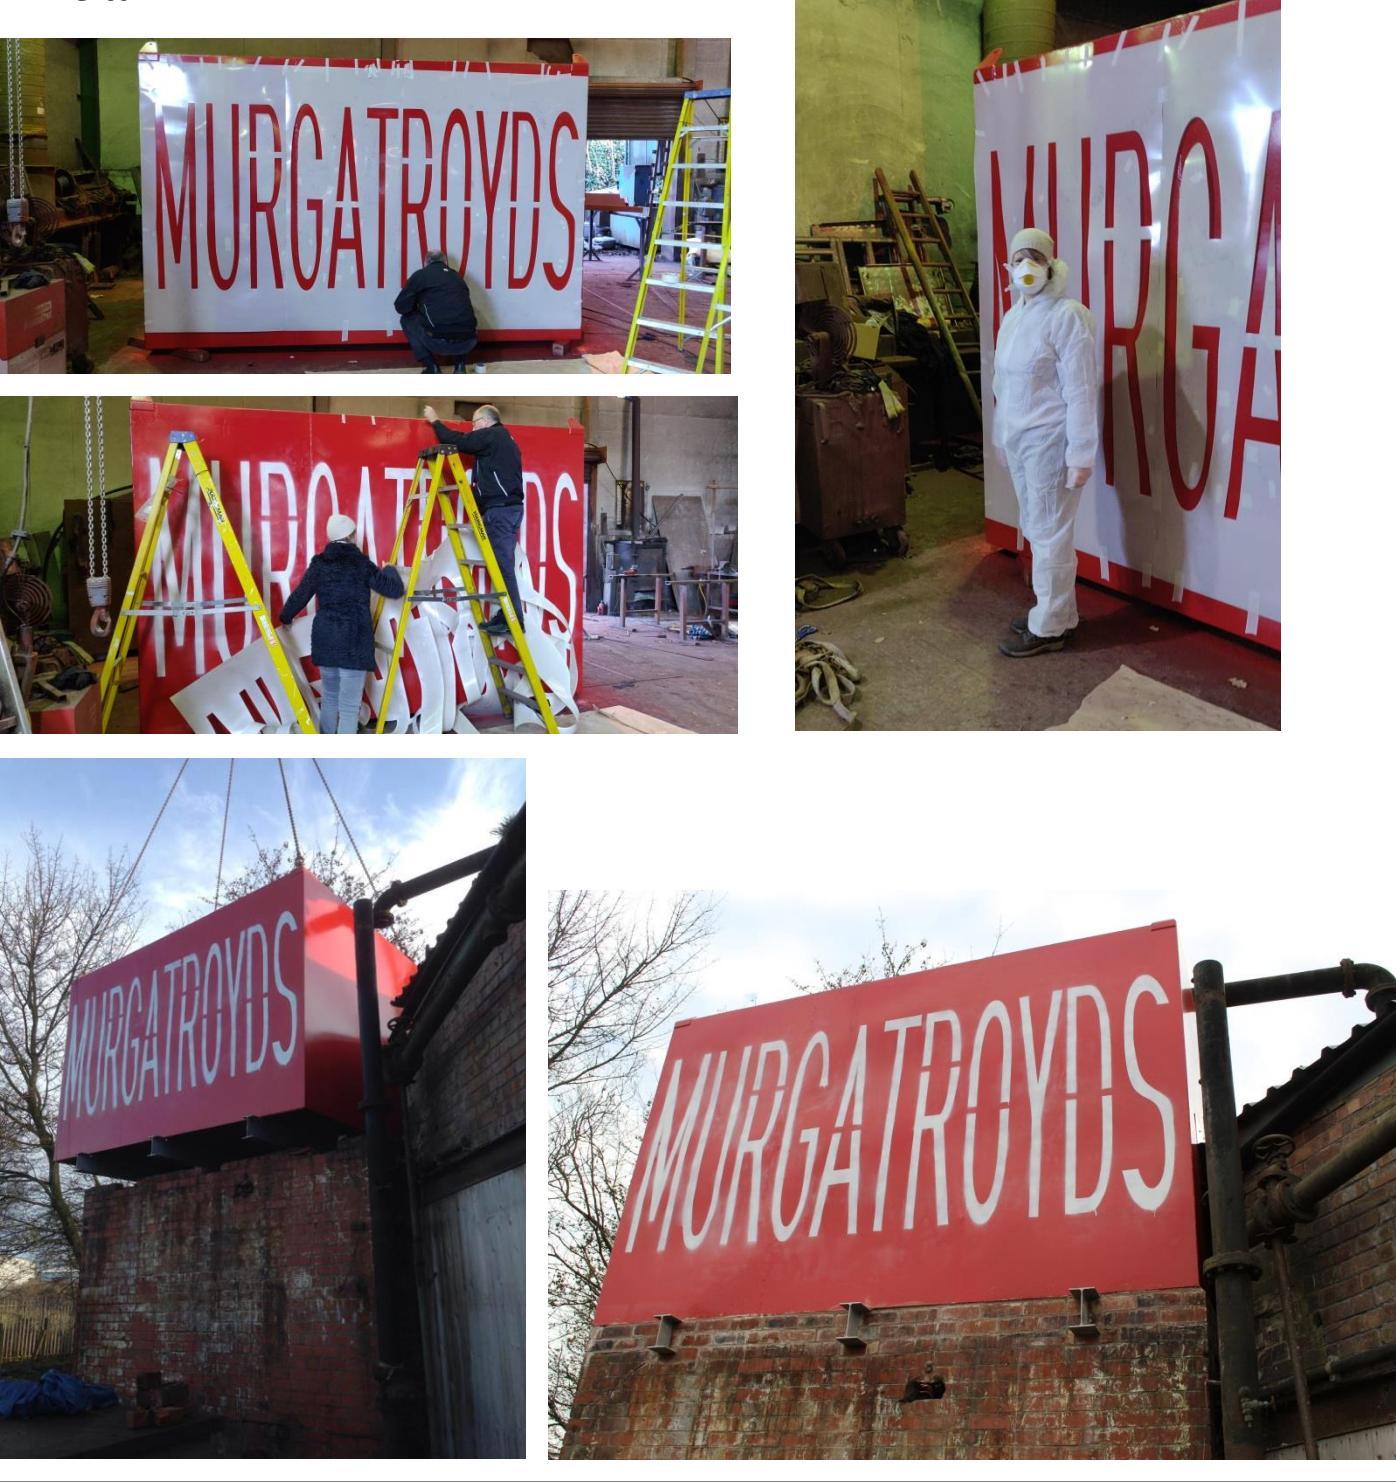
Murgatroyd's Brine pump Brine tank

Fabricated brine tank with additional I beams to replace the corroded ones. B R Fabrications painted the tank in red oxide as the original once was. Volunteers had a stencil made to the original design of the lettering and spray painted Murgatroyd's on the site facing side. Pictures show vols all suited and booted ready for action.

Crane Direct lifted the tank in place and the brickwork was re-instated.
