Revealing Murgatroyd's Project

PROGRESS REPORT PHOTOGRAPHS

Contained in this report is the photographic evidence of works being carried out at Murgatroyd's Brine Pumps as part of the Revealing Murgatroyd's Project. Appendix 13.

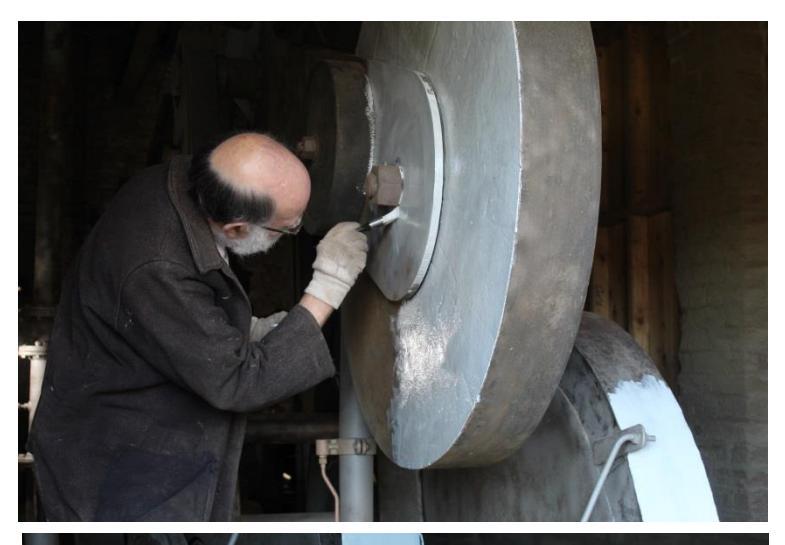
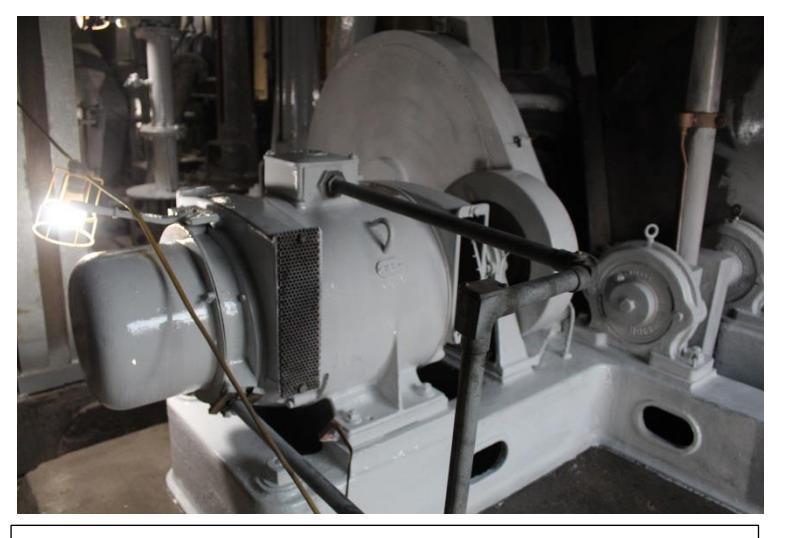
Murgatroyd's Brine pump Shot blasting and priming the metalwork

After the volunteers cleaned out the brine pump building and cleaned the brine pumps and machinery, we got the metal shot blasted. Volunteers painted the specialised metal primer over everything to protect the metal against any further erosion, the brass plaque uncovered was protected and all the maker's names now readable were documented for further research.

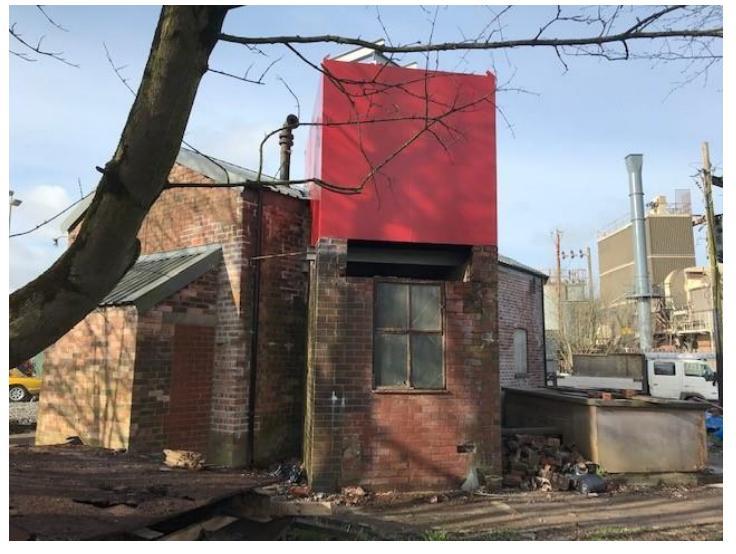
Murgatroyd's Brine pump Brine tank area restoration

Brine tank made like for like, new steels inserted over the switch room. Old steels all removed, brickwork re-done all around and tied back into structure.

New flashings each side of the brine tank, preventing any gaps, new infill brickwork above the window. Brine tank now complete.

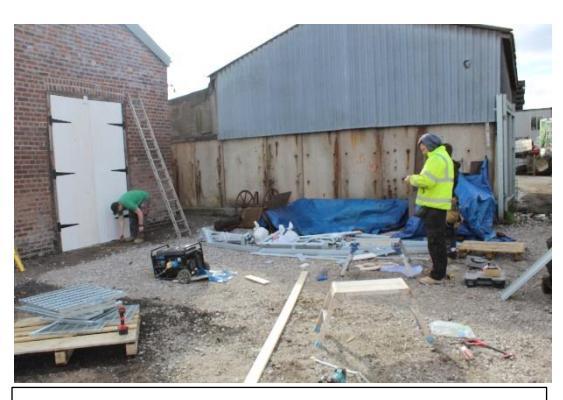
Murgatroyd's Brine pump Windows and doors

Replacement of large doors, with an inserted maintenance door, kept the original framework

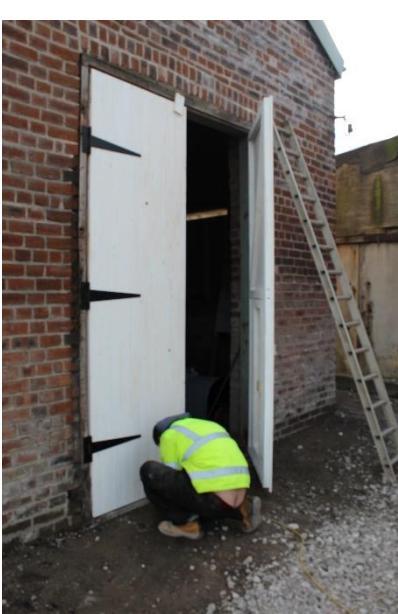
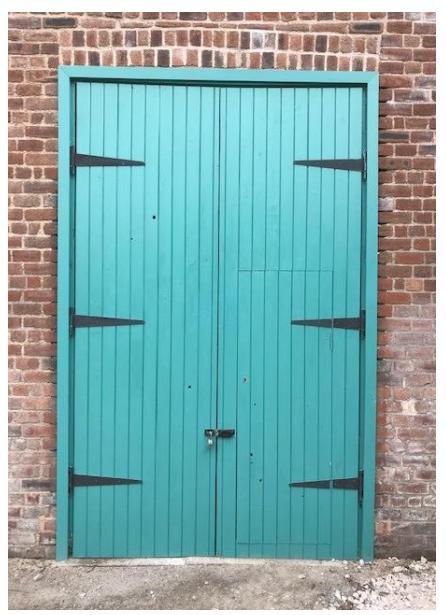
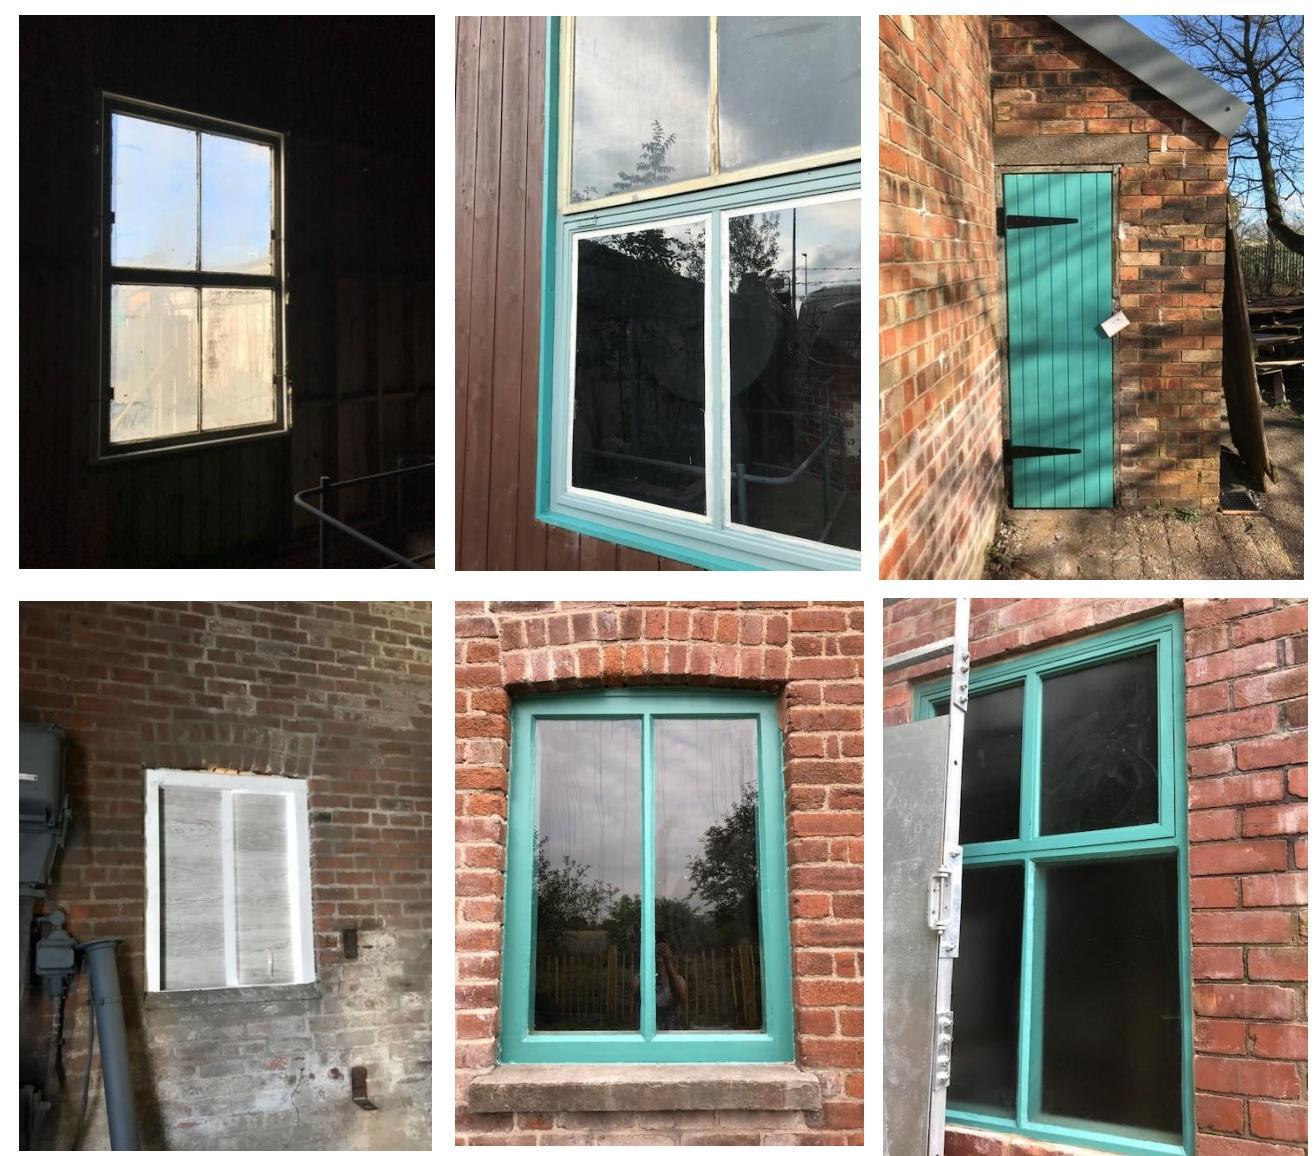
Original metal window at the rear of the building has been put back in on a new timber frame, other windows replaced like for like. Small door at the rear replaced and painted with brine pump colours. Timber work on the North East and South West of the building has been treated.

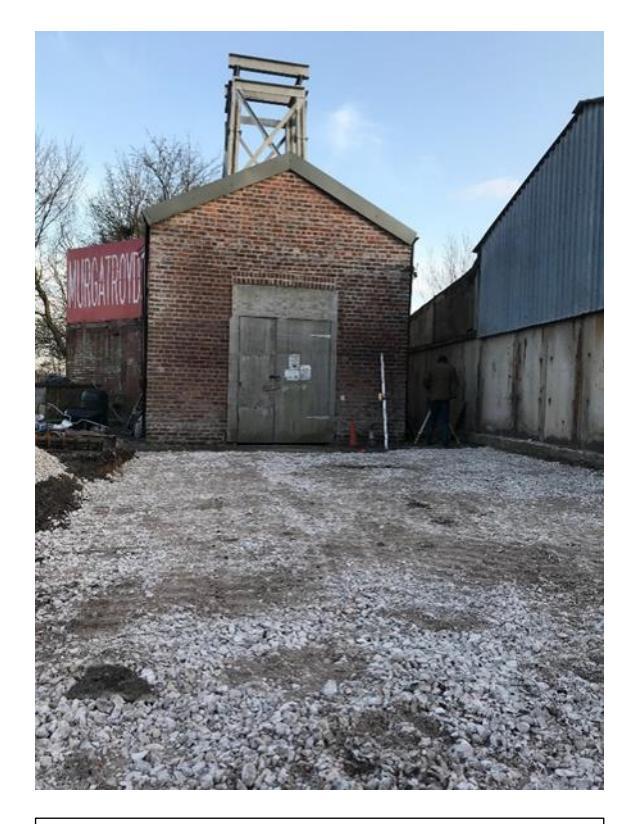
Murgatroyd's Brine pump Water ingress prevention, North side

The site has been used as a highways training space and storage site for years. The level of debris meant that the ground was much higher than the building. During heavy rain the water simply floods into the building, damaging the brickwork and the floor. The area was surveyed to find the right gradient, then tonnes of debris was removed to create a slight slope towards the brook, a pipe was inserted to drain the water and a layer of gravel to act as a soak away.

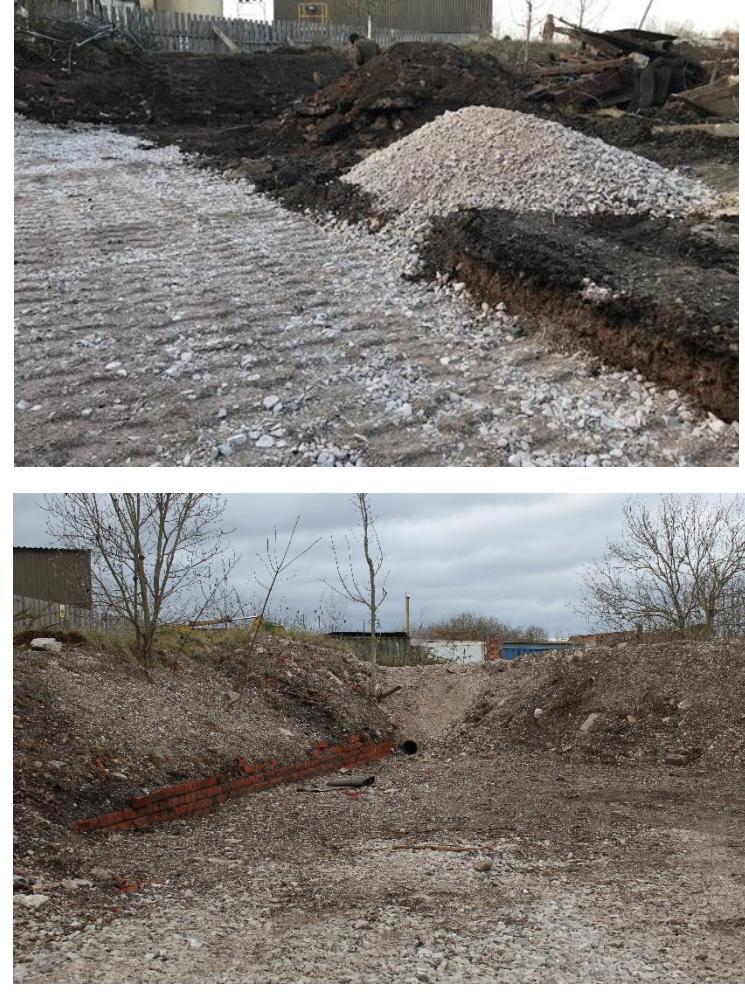
Volunteers put a safety fence at the base of the north east bund, and Cheshire Wildlife Trust planted native hedgerows on top of the north west bund and along the railway fence. Helps with drainage, habitats and screening.

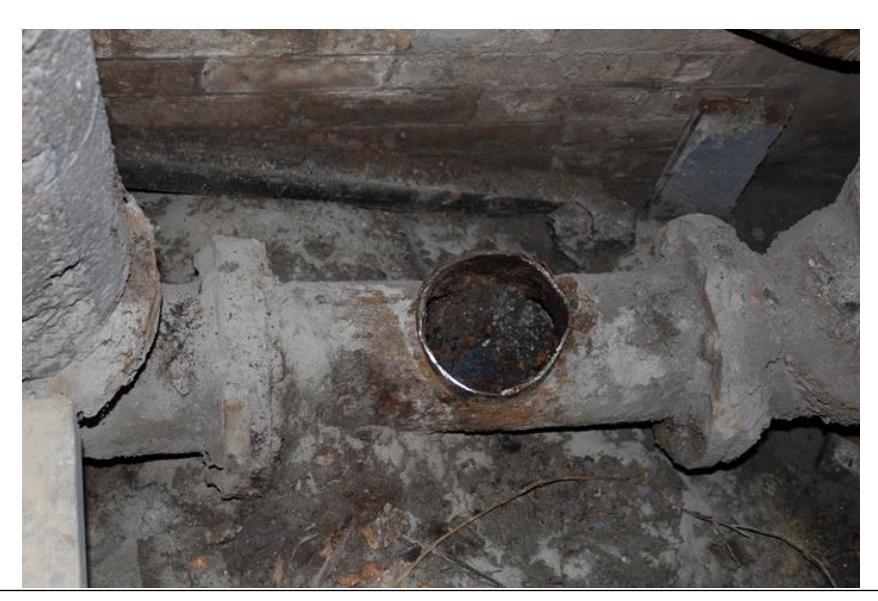
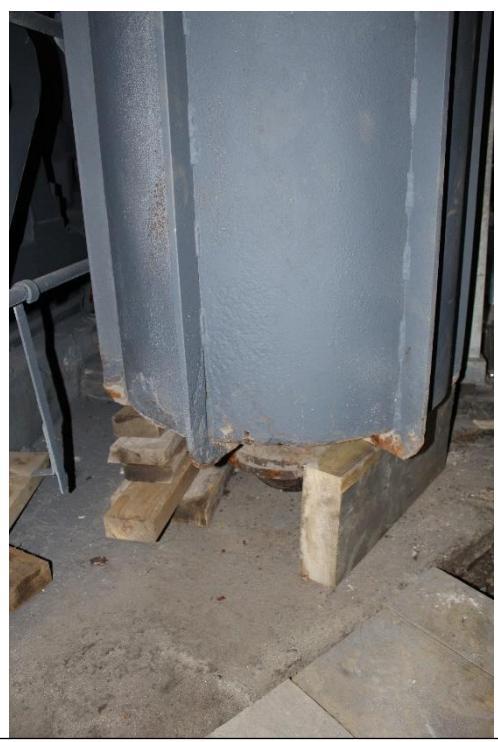
Murgatroyd's Brine pump Air Vessel and associated machinery

The timber and pipework under the air vessel was rotten, it was posing a risk hazard and leaning into the void. The pipe was separated and the whole vessel lifted to make timber repairs to the floor. The vessel was put onto a fabricated plinth and moved a few inches towards the gantry, so it rests on the concrete and gives space for people to work around it

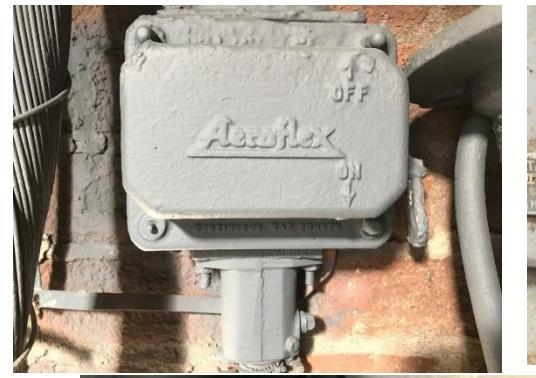
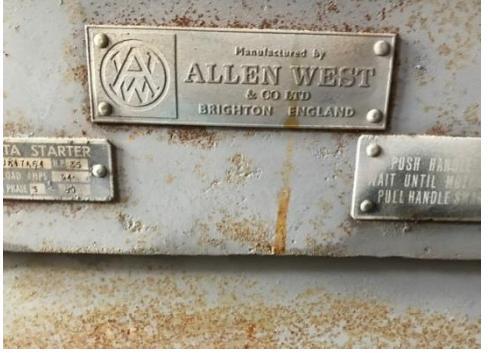
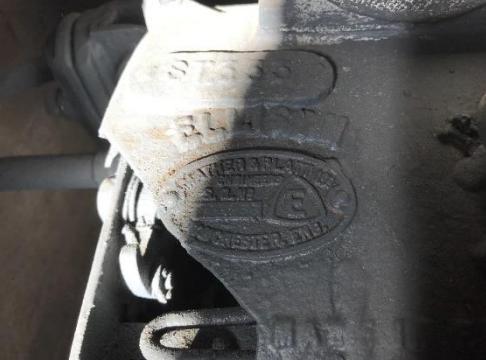
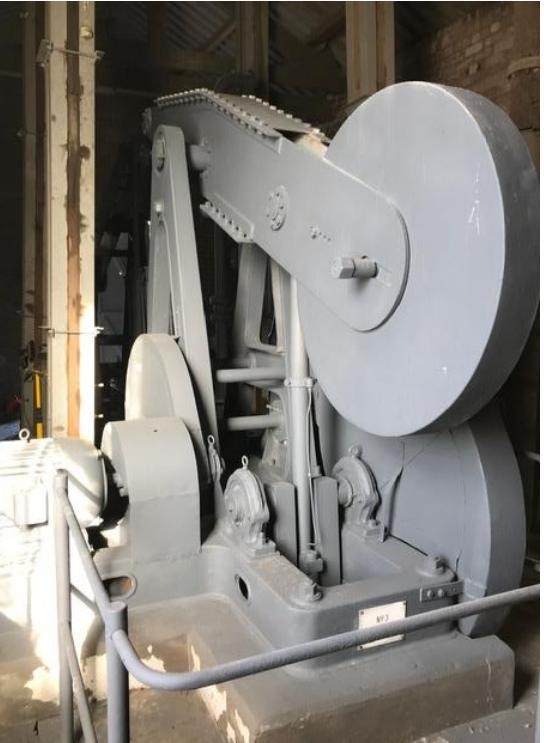
All metalwork has been sandblasted back to bare metal. We can now see makers labels as well as details not seen before. This will be used in future research. All metalwork was then painted with primer to protect from rust. Once the work in the building finished the machinery was painted in its original colours.

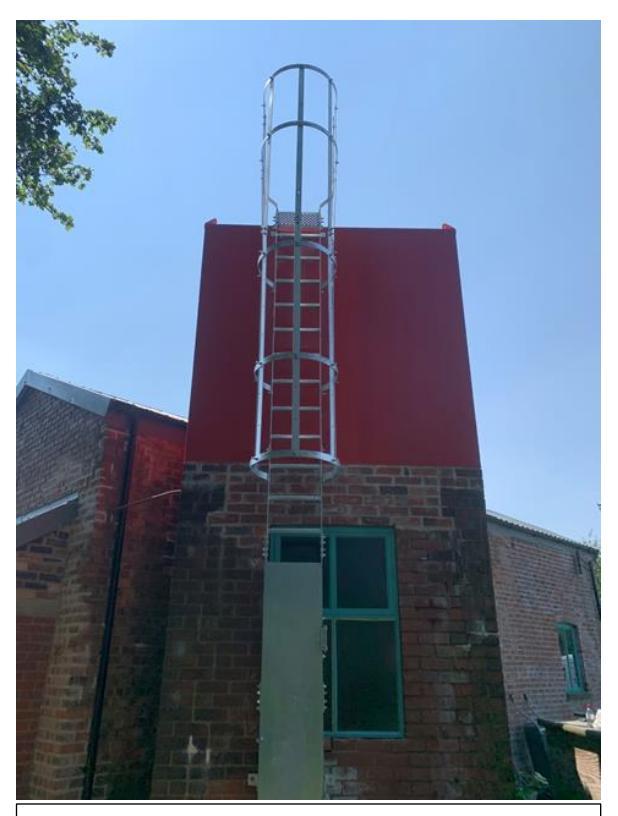
Murgatroyd's Brine pump Brine Pump Pipework Installation

Ladder and safety cage remade like for like. Pieces of original pipework were reattached and secured in place, two new pipe sections were fabricated to replace one beyond repair and one too heavy to be placed back. This piece of pipe is displayed on site.

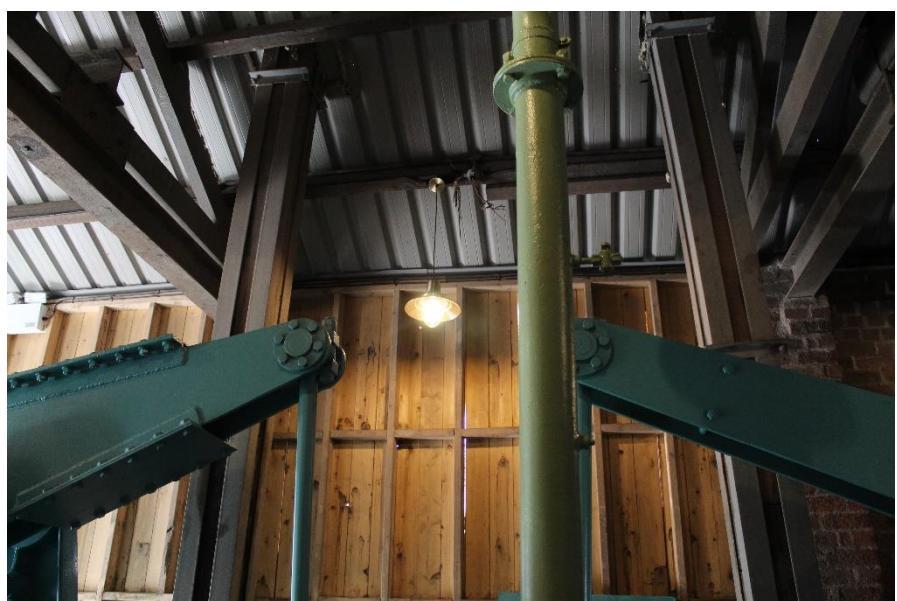
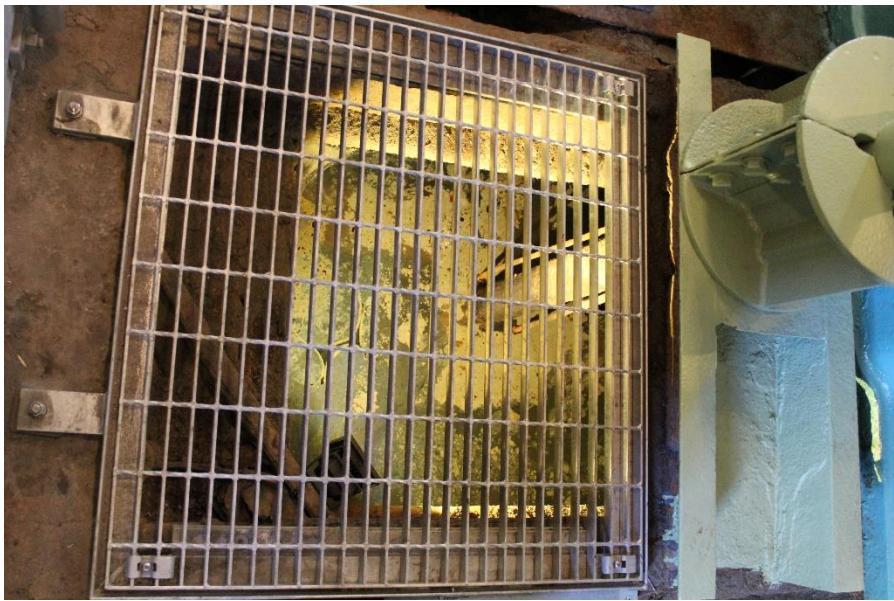
Murgatroyd's Brine pump Electricity installation

Electricity installed by S P Energy using the original transformer. Neil Hopley electricians fitted new switches, cabling, lights, emergency lighting, and supplied lampshades in a similar design to the old ones.

For interpretation purposes we had a light fitted inside the brine shaft and we have cabling to an area at the back of the building that will contain a display case.

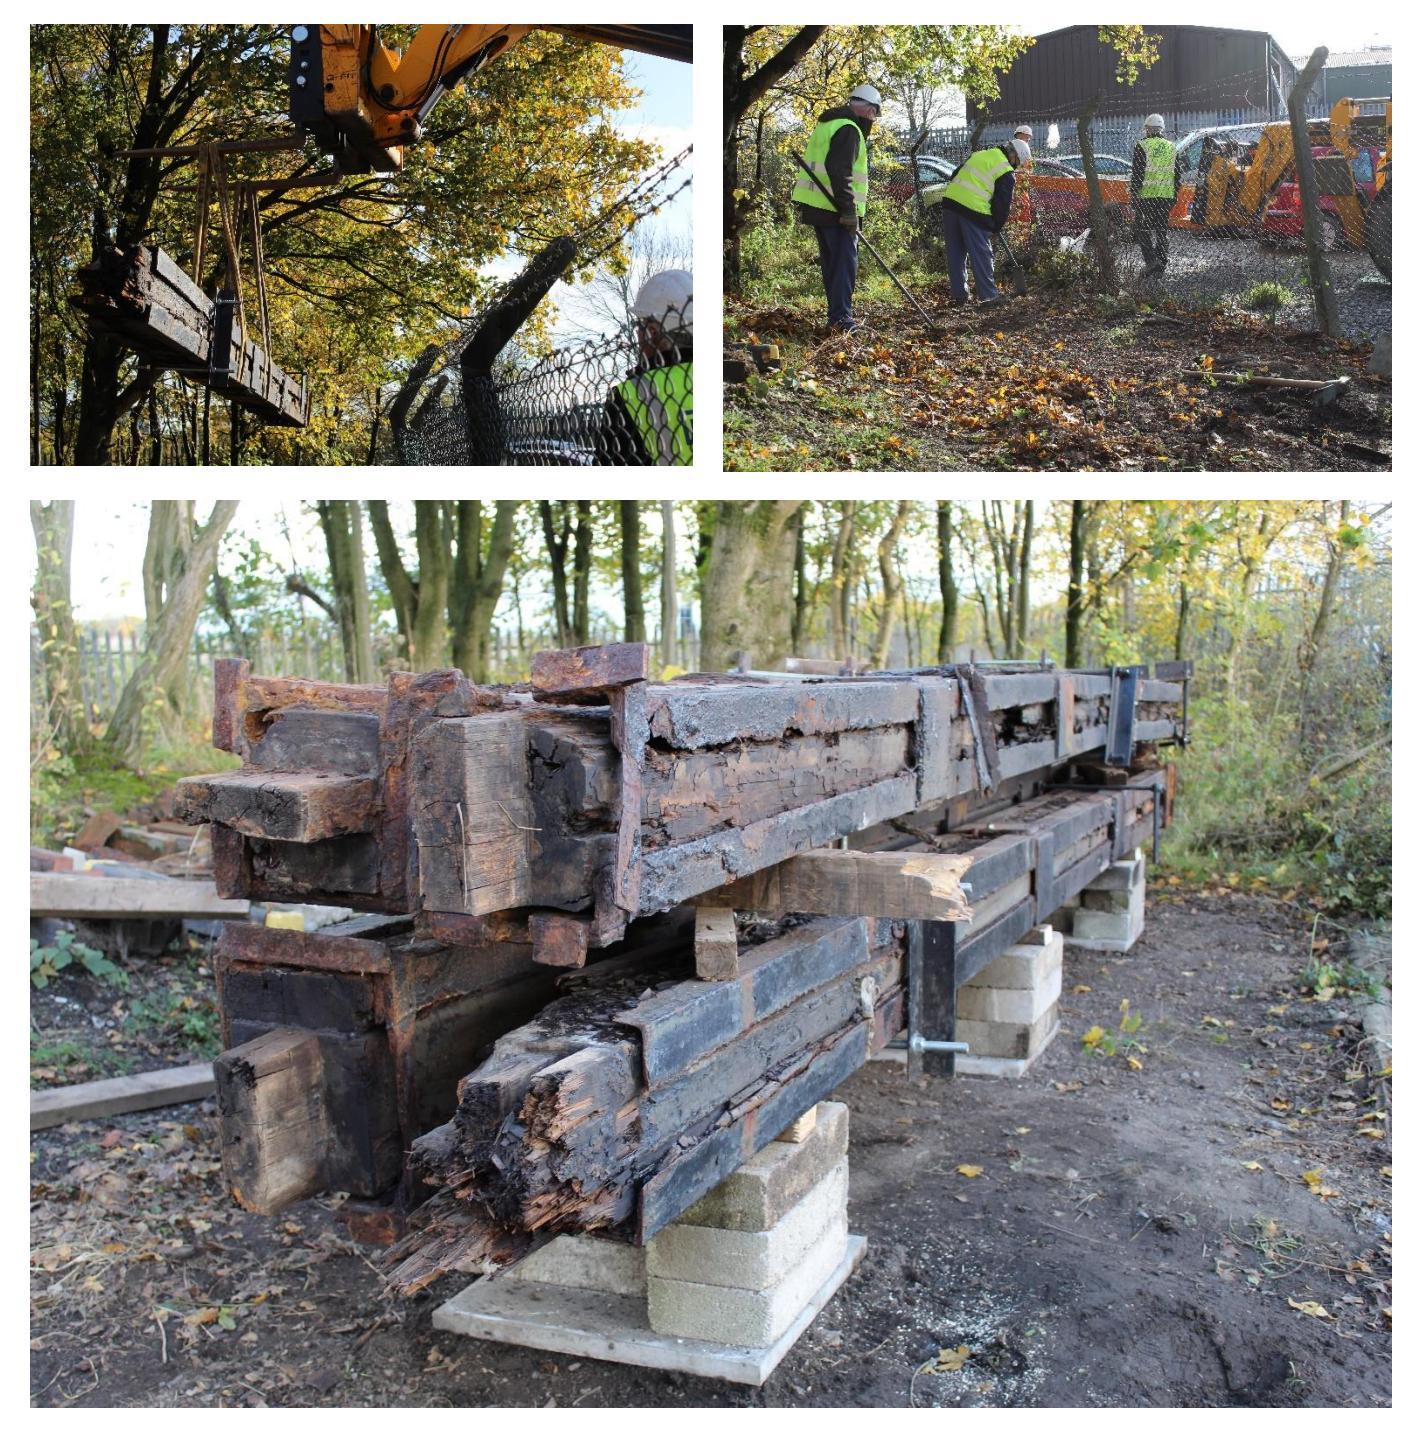
Murgatroyd's Brine pump Object displays and Lift

Above: photos of the original Gantry being moved, so that the ground underneath could be levelled off. Volunteers then made supports for the legs ensuring they were level before re-positioning the gantry legs on top. The area around the gantry has been cleared so that the cover can now be made in situ.

Left: Volunteers made brick supports for the piece of pipe that could not be put back on top of the brine tank

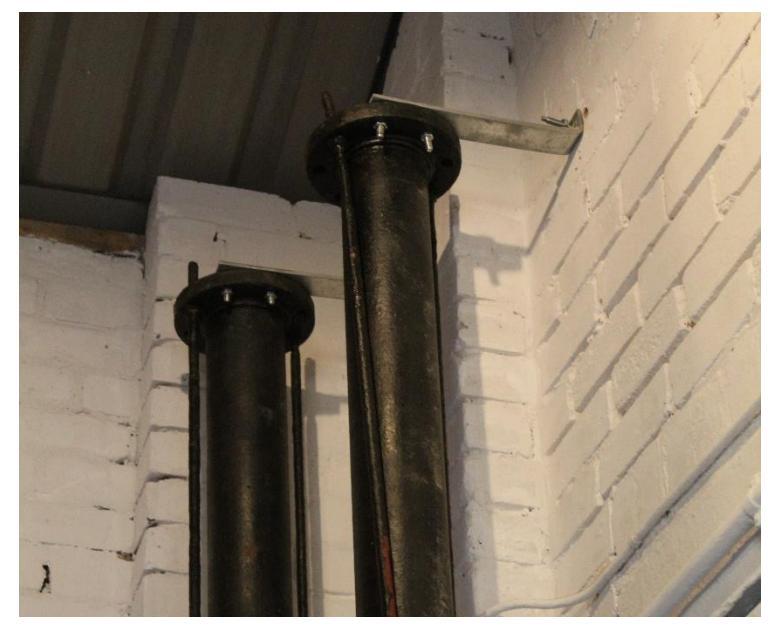
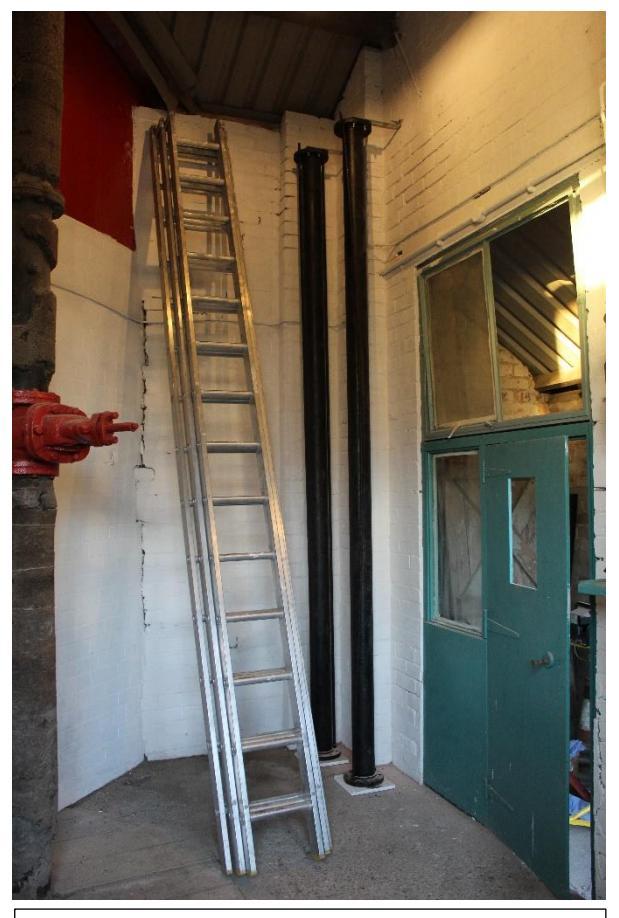
Murgatroyd's Brine pump Object displays and Lift

Lifting the sub pump and associated rods into place on plinths at the back of the pump house. Pump and pipes were then re-painted where required.

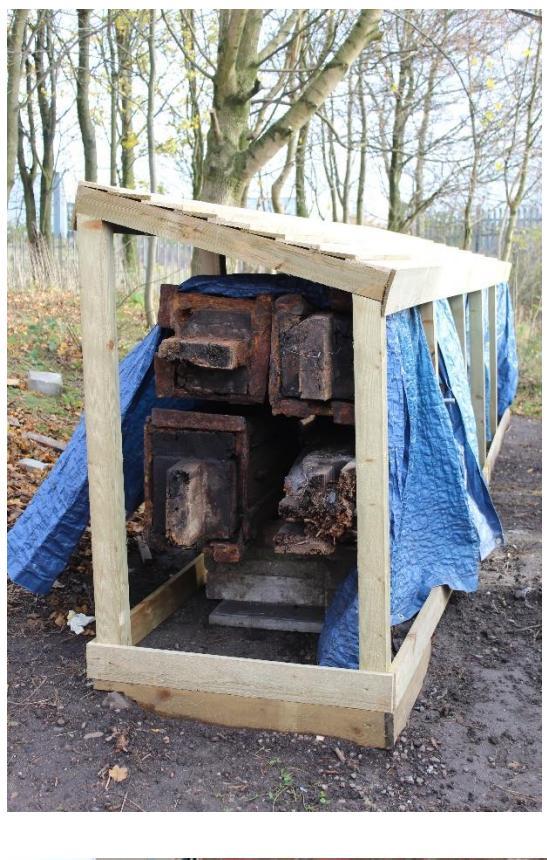
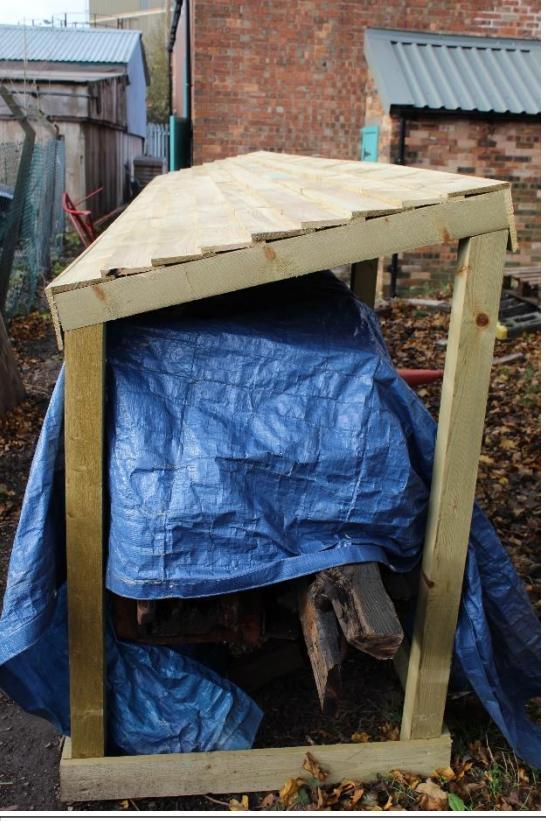
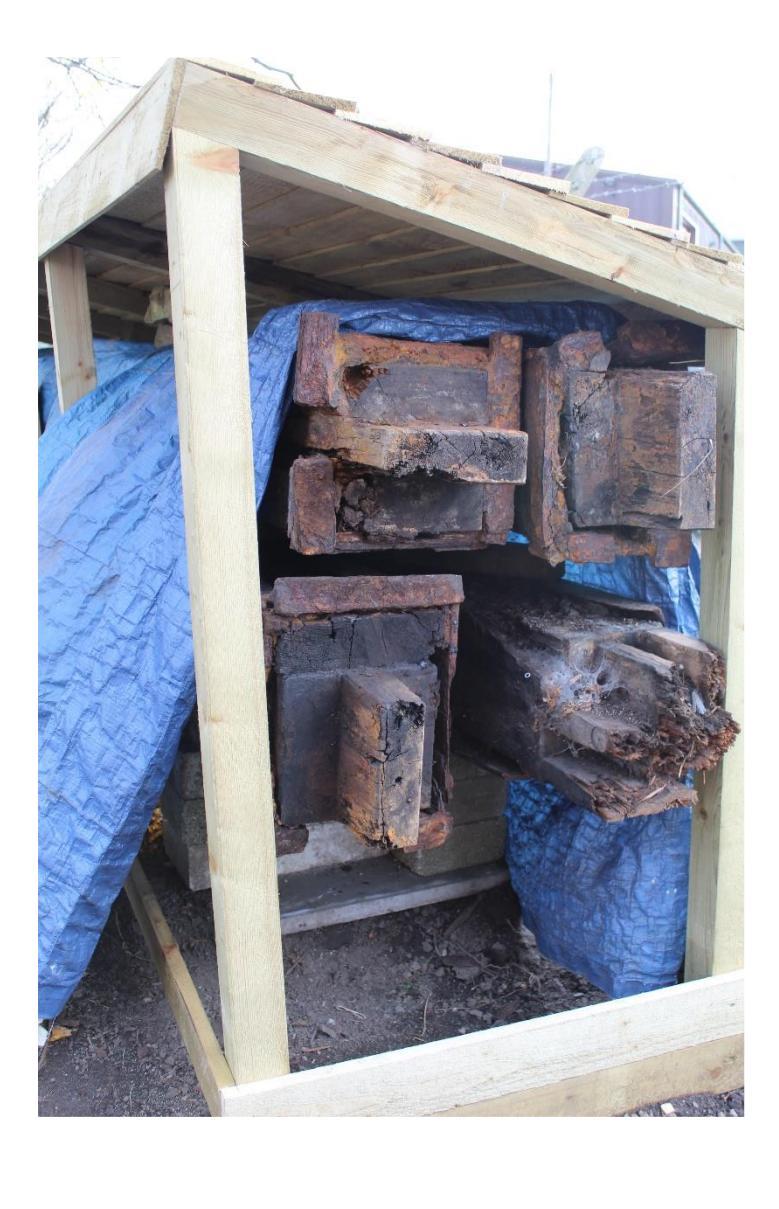
Murgatroyd's Brine pump Gantry legs timber cover

Cover for the gantry in the style of the Canal structures protecting lock timbers. Three plinths have been built underneath, with timber separators. Gantry will also be covered in between openings to protect them from the weather. The ground is cleared all around the area for visitor access. An information panel will also be added in the near future
