Project Title Murgatroyd's Brine Pump (Phase 2)
Client Middlewich Town Council
Location Middlewich

Drawing Title Proposed
North Elevation

Drawing ref	Job No	Drawing No	Revision
	8402	(05) 002	A

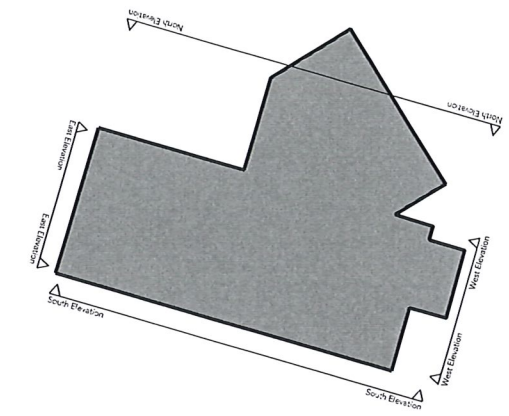
- Notes**
(To be read in conjunction with the Structural Engineers Report)
- Water tank and pipes to be reinstated
 - Windows and Doors to be replaced like for like
 - All vegetation growth & debris to be removed
 - Corrugated sheeting to be applied to external wall
 - Remove asbestos wall sheeting and replace with robust timber boarding.
 - Rebuild existing Lean-to
 - Area of wall to be rebuilt
 - Area of wall to be repointed
 - Demolition
 - Gantry to be removed, restored and replaced
- Refer to drawings (02) 010 - 013 for elevation repairs
